Contract #: 04-0120F4Cty: SF/ALA Rte: 80 PM: 13.2/13.9File #: 69.28**WELDING INSPECTION REPORT****Resident Engineer:** Siegenthaler, Peter**Address:** 333 Burma Road**City:** Oakland, CA 94607**Report No:** WIR-021346**Date Inspected:** 02-Feb-2011**Project Name:** SAS Superstructure**OSM Arrival Time:** 700**Prime Contractor:** American Bridge/Fluor Enterprises, a JV**OSM Departure Time:** 1700**Contractor:** Zhenhua Port Machinery Company, Ltd (ZPMC), Changxing Island **Location:** Shanghai, China**CWI Name:** Lv Li Qing**CWI Present:** Yes No**Inspected CWI report:** Yes No N/A**Rod Oven in Use:** Yes No N/A**Electrode to specification:** Yes No N/A**Weld Procedures Followed:** Yes No N/A**Qualified Welders:** Yes No N/A**Verified Joint Fit-up:** Yes No N/A**Approved Drawings:** Yes No N/A**Approved WPS:** Yes No N/A**Delayed / Cancelled:** Yes No N/A**Bridge No:** 34-0006**Component:** OBG**Summary of Items Observed:**

WELDING INSPECTION REPORT

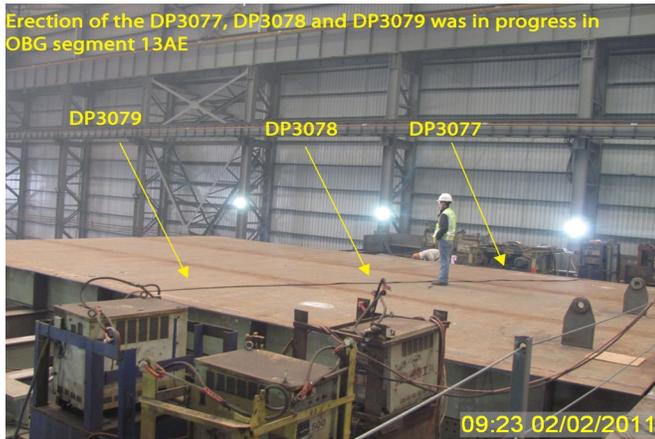
This Quality Assurance (QA) Inspector observed installation /erection of deck panel DP3077, DP3078 and DP3079 was in progress.
