**DEPARTMENT OF TRANSPORTATION**

Contract #: 04-0120F4Cty: SF/ALA Rte: 80 PM: 13.2/13.9File #: 69.28**WELDING INSPECTION REPORT****Resident Engineer:** Siegenthaler, Peter**Address:** 333 Burma Road**City:** Oakland, CA 94607**Report No:** WIR-021451**Date Inspected:** 27-Feb-2011**Project Name:** SAS Superstructure**OSM Arrival Time:** 700**Prime Contractor:** American Bridge/Fluor Enterprises, a JV**OSM Departure Time:** 1900**Contractor:** Zhenhua Port Machinery Company, Ltd (ZPMC), Changxing Island **Location:** Shanghai, China**CWI Name:** Xu tao**CWI Present:** Yes No**Inspected CWI report:** Yes No N/A**Rod Oven in Use:** Yes No N/A**Electrode to specification:** Yes No N/A**Weld Procedures Followed:** Yes No N/A**Qualified Welders:** Yes No N/A**Verified Joint Fit-up:** Yes No N/A**Approved Drawings:** Yes No N/A**Approved WPS:** Yes No N/A**Delayed / Cancelled:** Yes No N/A**Bridge No:** 34-0006**Component:** OBG Components**Summary of Items Observed:**

# WELDING INSPECTION REPORT

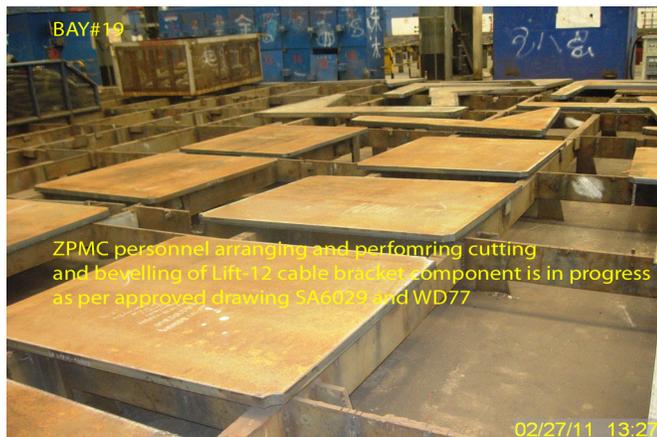
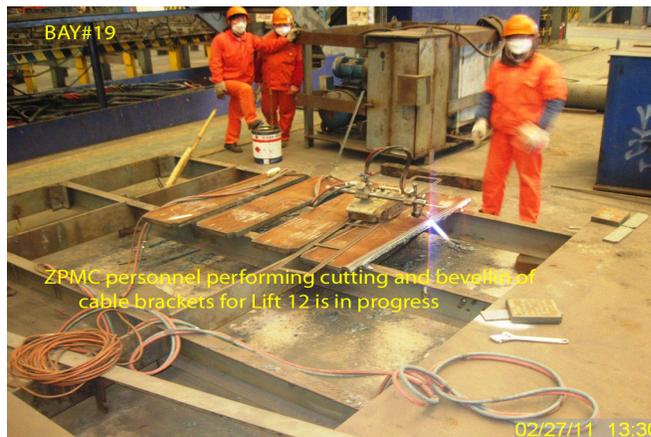
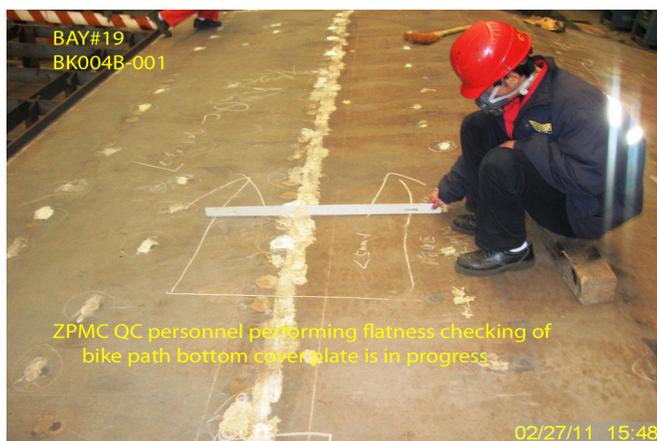
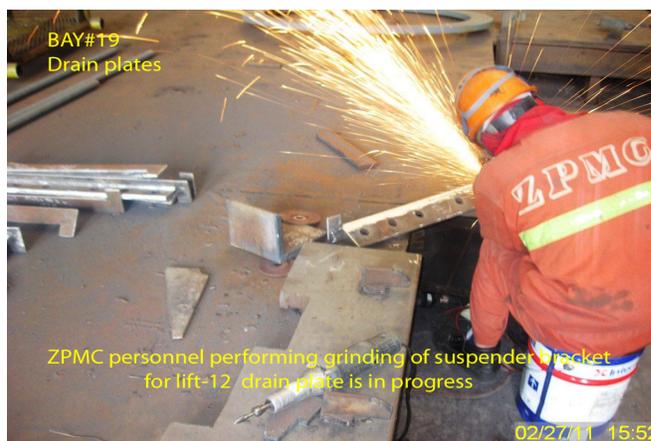
Cutting and beveling of Cable brackets for Lift 12 components like web plate and stiffener plates is identified as X6534, X6538, X6042, X6550, X6043 is in progress as per approved shop drawing SA6029 and approved WD77.

ZPMC QC personnel performing flatness checking of bike path bottom cover plate of BK004B-001 is in progress. During their observation they found some location flatness exceeds the limit that location needs to be repaired with HSR report.

Bike path bottom BK005A-002 cover plate plug welds flush grinding is in progress is appeared to comply with project specification.

Bike path BK004A-013 end closure plate PJP welds flush grinding is in progress is appeared to comply with project specification.

Drain plate Type 1, 3, and 3 of suspender bracket for Lift-12 grinding is in progress is appeared to comply with project specification.
