Contract #: 04-0120F4Cty: SF/ALA Rte: 80 PM: 13.2/13.9File #: 69.28**WELDING INSPECTION REPORT****Resident Engineer:** Siegenthaler, Peter**Address:** 333 Burma Road**City:** Oakland, CA 94607**Report No:** WIR-021455**Date Inspected:** 01-Feb-2011**Project Name:** SAS Superstructure**OSM Arrival Time:** 700**Prime Contractor:** American Bridge/Fluor Enterprises, a JV**OSM Departure Time:** 1500**Contractor:** Zhenhua Port Machinery Company, Ltd (ZPMC), Changxing Island **Location:** Shanghai, China**CWI Name:** Geng wei**CWI Present:** Yes No**Inspected CWI report:** Yes No N/A**Rod Oven in Use:** Yes No N/A**Electrode to specification:** Yes No N/A**Weld Procedures Followed:** Yes No N/A**Qualified Welders:** Yes No N/A**Verified Joint Fit-up:** Yes No N/A**Approved Drawings:** Yes No N/A**Approved WPS:** Yes No N/A**Delayed / Cancelled:** Yes No N/A**Bridge No:** 34-0006**Component:** OBG Components**Summary of Items Observed:**

WELDING INSPECTION REPORT

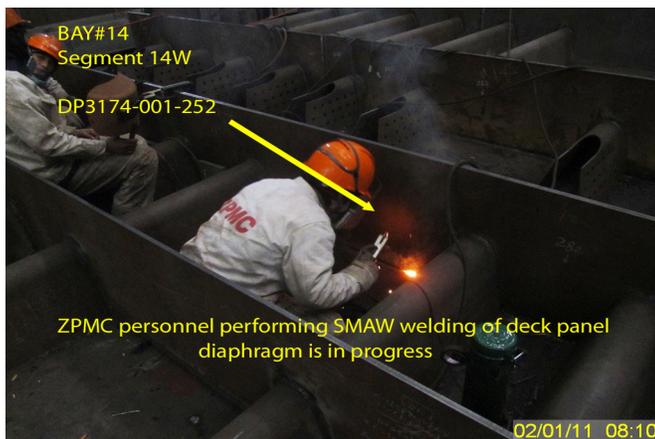
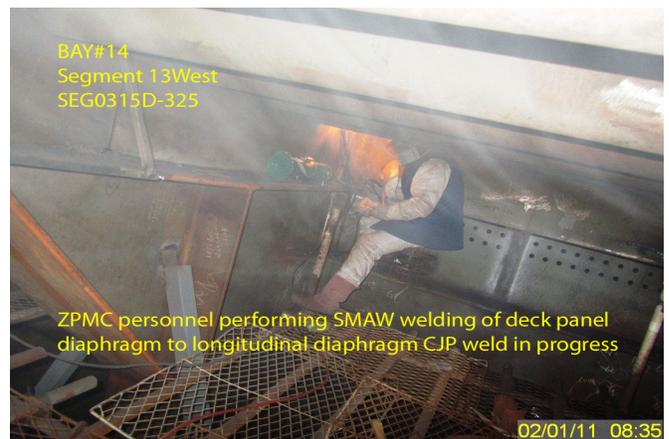
Shielded Metal Arc Welding (SMAW) repair welding of weld joint SEG3020D-052 located on Floor Beam to Bottom Plate of OBG Segment 14W. ZPMC Welders are identified as 066038. ZPMC Quality Control (QC) is identified as Mr. Wang Xiang Pin. The welding variables recorded by QC appeared to comply with the Applicable WPS-345-SMAW-2G (2F) – FCM – Repair, which is used as per Critical Welding Repair (CWR) B-CWR-2734-R1.

Flux Core Arc Welding (FCAW) welding of weld joint DP3169-001-018 located on Deck Panel of OBG Segment 14W. ZPMC Welder is identified as 067888. ABF Quality Control (QC) is identified as Mr. Shen Jian. The welding variables recorded by QC appeared to comply with the Applicable WPS-B-T-2232-ESAB.

Unless otherwise noted, all work observed on this date appeared to generally comply with applicable contract documents.
