DEPARTMENT OF TRANSPORTATION

Quality Assurance and Source Inspection

WELDING INSPECTION REPORT

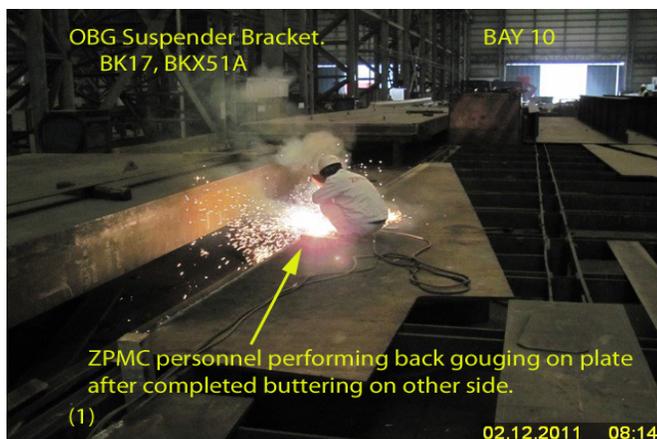
This QA Inspector observed ZPMC personnel identified in Bay 10, Performing Back gouging on backing plate of OBG suspender bracket, the plate were completed buttering from other side. Plate identified as BK17, (BKX51A). For more information see attached picture number 1.
