Contract #: 04-0120F4Cty: SF/ALA Rte: 80 PM: 13.2/13.9File #: 69.28**WELDING INSPECTION REPORT****Resident Engineer:** Siegenthaler, Peter**Address:** 333 Burma Road**City:** Oakland, CA 94607**Report No:** WIR-021611**Date Inspected:** 01-Mar-2011**Project Name:** SAS Superstructure**OSM Arrival Time:** 700**Prime Contractor:** American Bridge/Fluor Enterprises, a JV**OSM Departure Time:** 1900**Contractor:** Zhenhua Port Machinery Company, Ltd (ZPMC), Changxing Island **Location:** Shanghai, China**CWI Name:** Geng Wei**CWI Present:** Yes No**Inspected CWI report:** Yes No N/A**Rod Oven in Use:** Yes No N/A**Electrode to specification:** Yes No N/A**Weld Procedures Followed:** Yes No N/A**Qualified Welders:** Yes No N/A**Verified Joint Fit-up:** Yes No N/A**Approved Drawings:** Yes No N/A**Approved WPS:** Yes No N/A**Delayed / Cancelled:** Yes No N/A**Bridge No:** 34-0006**Component:** OBG Components**Summary of Items Observed:**

WELDING INSPECTION REPORT

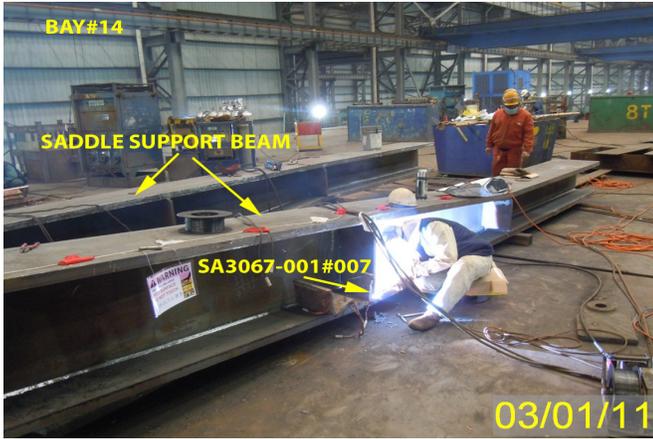
Weld joint #007 located on 13AE, saddle support beam SA3067-001. Welder is identified as 044824. ZPMC Quality Control (QC) Inspector is identified as Liu Hui Jie. The welding variables recorded by QC appeared to comply with the WPS-B-T-2232-ESAB. (See attached photo)
