Quality Assurance and Source Inspection

Contract #: 04-0120F4Cty: SF/ALA Rte: 80 PM: 13.2/13.9File #: 69.28**WELDING INSPECTION REPORT****Resident Engineer:** Siegenthaler, Peter**Address:** 333 Burma Road**City:** Oakland, CA 94607**Report No:** WIR-021656**Date Inspected:** 08-Mar-2011**Project Name:** SAS Superstructure**OSM Arrival Time:** 700**Prime Contractor:** American Bridge/Fluor Enterprises, a JV**OSM Departure Time:** 1900**Contractor:** Zhenhua Port Machinery Company, Ltd (ZPMC), Changxing Island **Location:** Shanghai, China**CWI Name:** An Qing Xiang.**CWI Present:** Yes No**Inspected CWI report:** Yes No N/A**Rod Oven in Use:** Yes No N/A**Electrode to specification:** Yes No N/A**Weld Procedures Followed:** Yes No N/A**Qualified Welders:** Yes No N/A**Verified Joint Fit-up:** Yes No N/A**Approved Drawings:** Yes No N/A**Approved WPS:** Yes No N/A**Delayed / Cancelled:** Yes No N/A**Bridge No:** 34-0006**Component:** OBG components.**Summary of Items Observed:**

WELDING INSPECTION REPORT

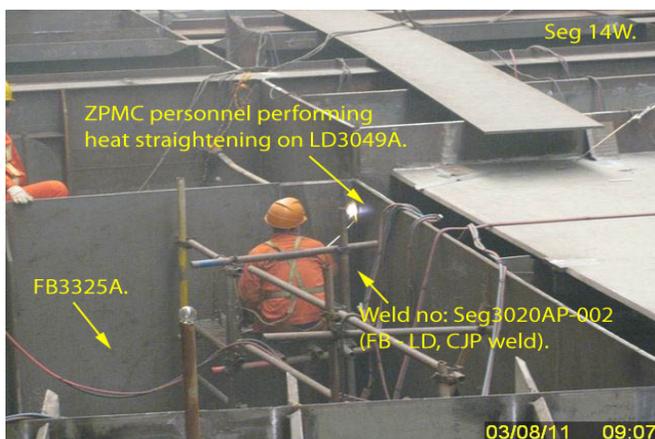
This QA Inspector observed ZPMC personnel performing heat straightening on LD3049A (at weld joint no: Seg3020X-008). Heat straightening was done as per heat straightening report (HSR) no: HSR1-(B)-10171. However, it was observed that the Ultrasonic Testing of weld joint no: Seg3020X-008 [Longitudinal diaphragm (LD) 3049A to Floor Beam (FB) 3325A], CJP weld, is previously completed (on 05/03/11) by ZPMC and Caltrans QA. This QA informed about this issue to ZPMC CWI Mr. An Qing Xiang. ZPMC QC agreed that they will re-notify for NDT of this weld after completion of heat straightening. See attached photo for further information.
