Contract #: 04-0120F4Cty: SF/ALA Rte: 80 PM: 13.2/13.9File #: 69.28**WELDING INSPECTION REPORT****Resident Engineer:** Siegenthaler, Peter**Address:** 333 Burma Road**City:** Oakland, CA 94607**Report No:** WIR-021738**Date Inspected:** 23-Feb-2011**Project Name:** SAS Superstructure**OSM Arrival Time:** 1900**Prime Contractor:** American Bridge/Fluor Enterprises, a JV**OSM Departure Time:** 700**Contractor:** Zhenhua Port Machinery Company, Ltd (ZPMC), Changxing Island **Location:** Shanghai China**CWI Name:** See below**CWI Present:** Yes No**Inspected CWI report:** Yes No N/A**Rod Oven in Use:** Yes No N/A**Electrode to specification:** Yes No N/A**Weld Procedures Followed:** Yes No N/A**Qualified Welders:** Yes No N/A**Verified Joint Fit-up:** Yes No N/A**Approved Drawings:** Yes No N/A**Approved WPS:** Yes No N/A**Delayed / Cancelled:** Yes No N/A**Bridge No:** 34-0006**Component:** OBG**Summary of Items Observed:**

WELDING INSPECTION REPORT

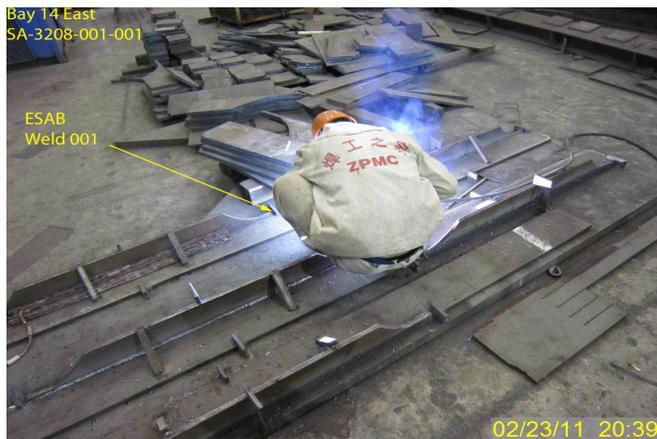
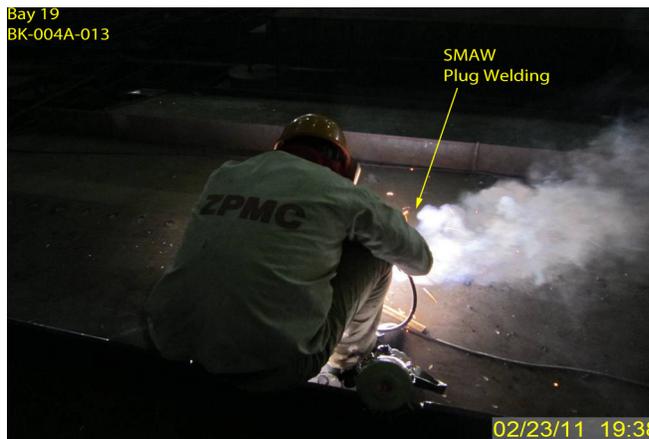
Unless otherwise noted, all work observed on this date appeared to be in general compliance with the applicable contract documents.
