**DEPARTMENT OF TRANSPORTATION**

Contract #: 04-0120F4Cty: SF/ALA Rte: 80 PM: 13.2/13.9File #: 69.28**WELDING INSPECTION REPORT****Resident Engineer:** Siegenthaler, Peter**Address:** 333 Burma Road**City:** Oakland, CA 94607**Report No:** WIR-021859**Date Inspected:** 20-Mar-2011**Project Name:** SAS Superstructure**OSM Arrival Time:** 700**Prime Contractor:** American Bridge/Fluor Enterprises, a JV**OSM Departure Time:** 1900**Contractor:** Zhenhua Port Machinery Company, Ltd (ZPMC), Changxing Island **Location:** Shanghai, China**CWI Name:** Zhou Zhong Hai**CWI Present:** Yes No**Inspected CWI report:** Yes No N/A**Rod Oven in Use:** Yes No N/A**Electrode to specification:** Yes No N/A**Weld Procedures Followed:** Yes No N/A**Qualified Welders:** Yes No N/A**Verified Joint Fit-up:** Yes No N/A**Approved Drawings:** Yes No N/A**Approved WPS:** Yes No N/A**Delayed / Cancelled:** Yes No N/A**Bridge No:** 34-0006**Component:** OBG Segments**Summary of Items Observed:**

Segment 13AE

### Segment 12CE

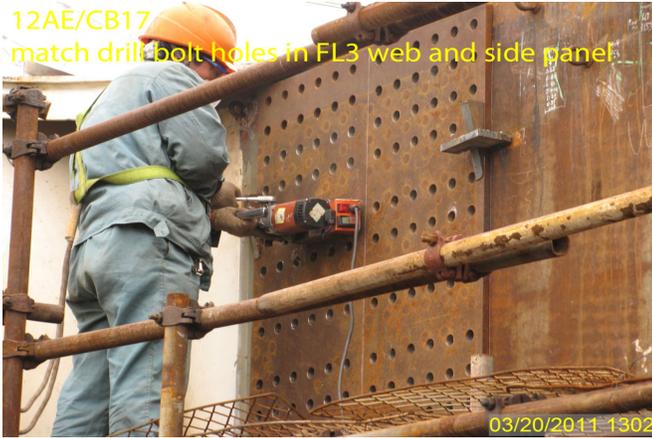
This QA Inspector observed match drilling of bolt holes for the bolted splice plate at CB Side Panel and 12AE FL3 web at panel points 110 and 112.

12AE/CB17  
match drill bolt holes in FL3 web and side panel

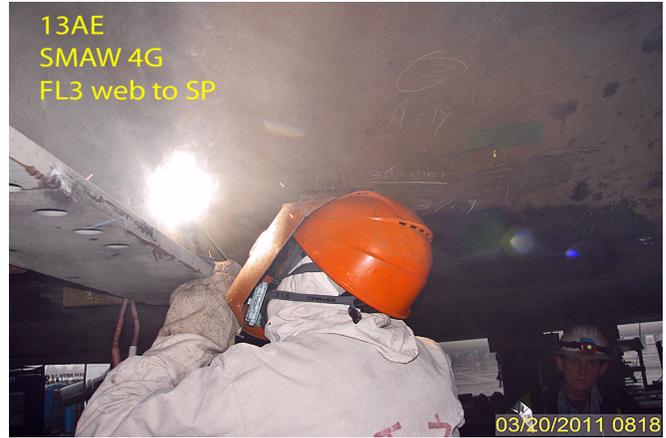
This QA Inspector observed Shielded Metal Arc Welding (SMAW) in progress of a UT repair on a Complete Joint Penetration (CJP) weld joint. The Weld joint is designated SEG3007AD-043, FL3 web to Side Plate. The welder is identified as #066183 and was observed welding in the 4G (overhead) position using approved Welding Procedure Specification WPS-345-4G (4F)-FCM-repair-1 for WR19463.

13AE  
SMAW 4G  
FL3 web to SP

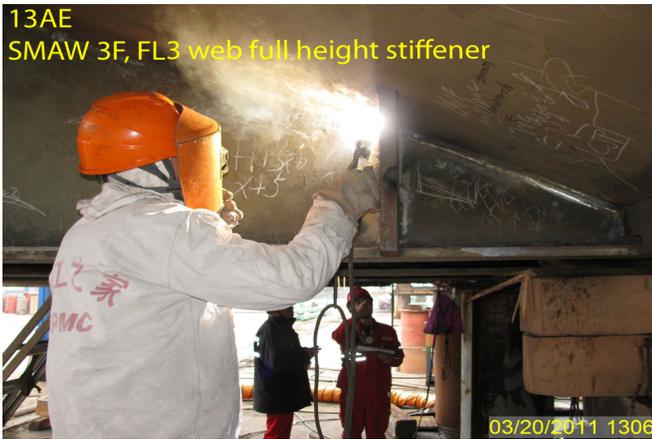
This QA Inspector observed Shielded Metal Arc Welding (SMAW) in progress of a fillet weld joint. The Weld joint is designated SEG3007K-026, 027, full height stiffener to FL3 web. The welder is identified as #037743 and

was observed welding in the 3F (vertical) positions using approved Welding Procedure Specification WPS-B-P-2113-FCM-1.

This QA Inspector observed Shielded Metal Arc Welding (SMAW) in progress of a fillet weld joint. The Weld joint is designated SEG3007H-026, 027, full height stiffener to FL3 web. The welder is identified as #037743 and was observed welding in the 3F (vertical) positions using approved Welding Procedure Specification WPS-B-P-2113-FCM-1.

13AE  
SMAW 3F, FL3 web full height stiffener

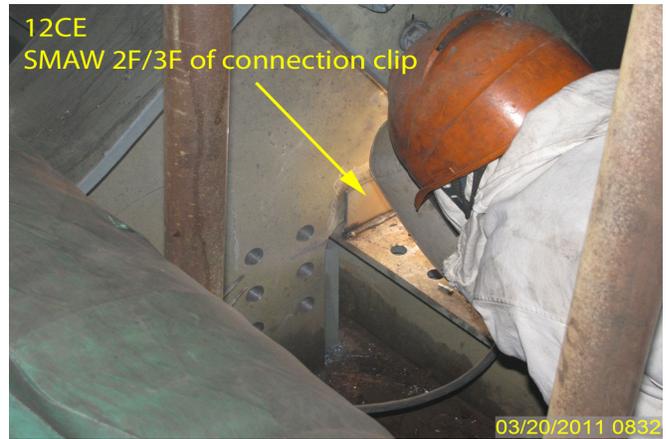
This QA Inspector observed Shielded Metal Arc Welding (SMAW) in progress of a fillet weld joint. The Weld joint is designated SEG3003M-271, Bottom Plate WT stiffener connection clip to Floor Beam at panel point 115. The welder is identified as #037032 and was observed welding in the 2F (horizontal) and 3F (vertical) positions using approved Welding Procedure Specification WPS-B-P-2112-FCM-1 and WPS-B-P-2113-FCM-1.

This QA Inspector observed Shielded Metal Arc Welding (SMAW) in progress of a fillet weld joint. The Weld joint is designated SEG3003M-038, 039, connection clip to Bottom Plate WT stiffener flange at panel point 115. The welder is identified as #037032 and was observed welding in the 2F (horizontal) positions using approved Welding Procedure Specification WPS-B-P-2112-FCM-1.

This QA Inspector observed Shielded Metal Arc Welding (SMAW) in progress of a fillet weld joint. The Weld joint is designated SEG3003N-271, Bottom Plate WT stiffener connection clip to Floor Beam at panel point 115. The welder is identified as #037032 and was observed welding in the 2F (horizontal) and 3F (vertical) positions using approved Welding Procedure Specification WPS-B-P-2112-FCM-1 and WPS-B-P-2113-FCM-1.

This QA Inspector observed Shielded Metal Arc Welding (SMAW) in progress of a fillet weld joint. The Weld joint is designated SEG3003N-038, 039, connection clip to Bottom Plate WT stiffener flange at panel point 115. The welder is identified as #037032 and was observed welding in the 2F (horizontal) positions using approved Welding Procedure Specification WPS-B-P-2112-FCM-1.

12CE  
SMAW 2F/3F of connection clip
