DEPARTMENT OF TRANSPORTATION

Contract #: 04-0120F4Cty: SF/ALA Rte: 80 PM: 13.2/13.9File #: 69.28**WELDING INSPECTION REPORT****Resident Engineer:** Siegenthaler, Peter**Address:** 333 Burma Road**City:** Oakland, CA 94607**Report No:** WIR-021908**Date Inspected:** 17-Feb-2011**Project Name:** SAS Superstructure**OSM Arrival Time:** 700**Prime Contractor:** American Bridge/Fluor Enterprises, a JV**OSM Departure Time:** 1900**Contractor:** Zhenhua Port Machinery Company, Ltd (ZPMC), Changxing Island **Location:** Shanghai, China**CWI Name:** Li Yan Hua**CWI Present:** Yes No**Inspected CWI report:** Yes No N/A**Rod Oven in Use:** Yes No N/A**Electrode to specification:** Yes No N/A**Weld Procedures Followed:** Yes No N/A**Qualified Welders:** Yes No N/A**Verified Joint Fit-up:** Yes No N/A**Approved Drawings:** Yes No N/A**Approved WPS:** Yes No N/A**Delayed / Cancelled:** Yes No N/A**Bridge No:** 34-0006**Component:** OBG Components**Summary of Items Observed:**

WELDING INSPECTION REPORT

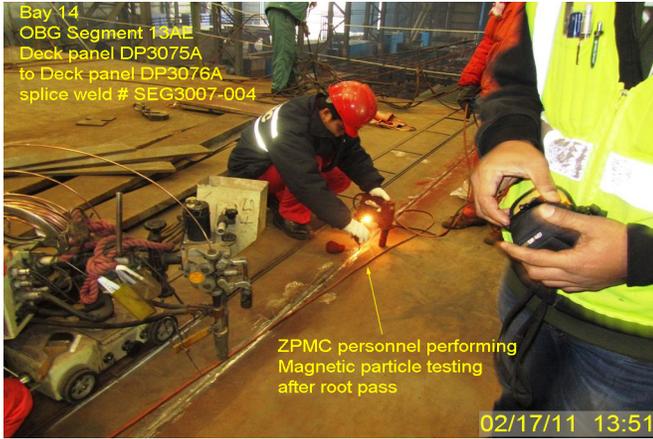
This QA Inspector observed ZPMC qualified NDT personnel perform Magnetic Particle Testing on OBG Segment 13AE, deck panel DP3075A to deck panel DP3076A splice weld after root pass. Weld joint is identified as SEG3007-004. See attached picture.
