Quality Assurance and Source Inspection

Contract #: 04-0120F4Cty: SF/ALA Rte: 80 PM: 13.2/13.9File #: 69.28**WELDING INSPECTION REPORT****Resident Engineer:** Siegenthaler, Peter**Address:** 333 Burma Road**City:** Oakland, CA 94607**Report No:** WIR-021973**Date Inspected:** 27-Feb-2011**Project Name:** SAS Superstructure**OSM Arrival Time:** 1900**Prime Contractor:** American Bridge/Fluor Enterprises, a JV**OSM Departure Time:** 700**Contractor:** Zhenhua Port Machinery Company, Ltd (ZPMC), Changxing Island **Location:** Shanghai, China**CWI Name:** See below**CWI Present:** Yes No**Inspected CWI report:** Yes No N/A**Rod Oven in Use:** Yes No N/A**Electrode to specification:** Yes No N/A**Weld Procedures Followed:** Yes No N/A**Qualified Welders:** Yes No N/A**Verified Joint Fit-up:** Yes No N/A**Approved Drawings:** Yes No N/A**Approved WPS:** Yes No N/A**Delayed / Cancelled:** Yes No N/A**Bridge No:** 34-0006**Component:** OBG**Summary of Items Observed:**

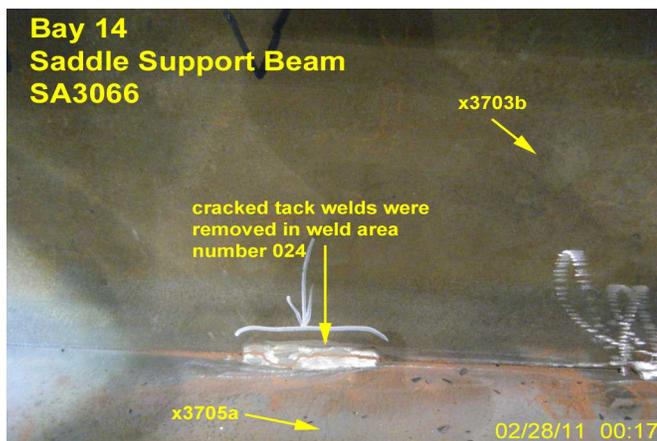
Components; OBG 13E (see photo below)

PCMK: SA3066-001

Weld No: 019,020,024,025

Welder: 050242, 055491, 055564, 044795

WPS-B-T-2132-ESAB

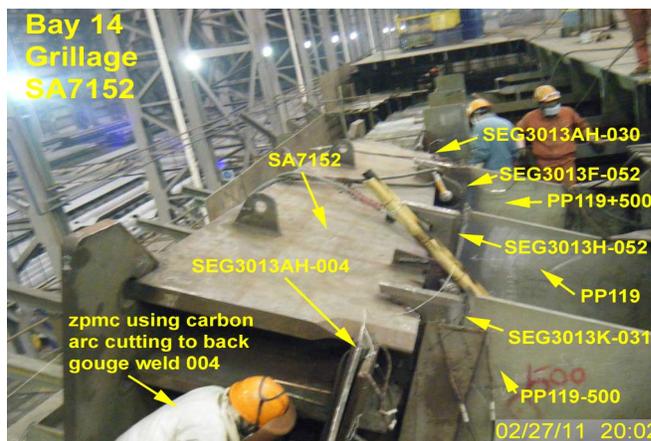
This Caltrans QA Inspector observed at random intervals ZPMC performing grinding of welds located on Grillage SA-7152 at various locations due to contour grinding and visual indications as identified by ZPMC QC Inspectors.
(see photo below)
