Contract #: 04-0120F4Cty: SF/ALA Rte: 80 PM: 13.2/13.9File #: 69.28**WELDING INSPECTION REPORT****Resident Engineer:** Siegenthaler, Peter**Address:** 333 Burma Road**City:** Oakland, CA 94607**Report No:** WIR-022140**Date Inspected:** 26-Mar-2011**Project Name:** SAS Superstructure**OSM Arrival Time:** 700**Prime Contractor:** American Bridge/Fluor Enterprises, a JV**OSM Departure Time:** 1900**Contractor:** Zhenhua Port Machinery Company, Ltd (ZPMC), Changxing Island **Location:** Shanghai, China

**Bridge No:** 34-0006**Component:** Orthotropic Box Girder( OBG)**Summary of Items Observed:**

OBG Trial Assembly open yard.

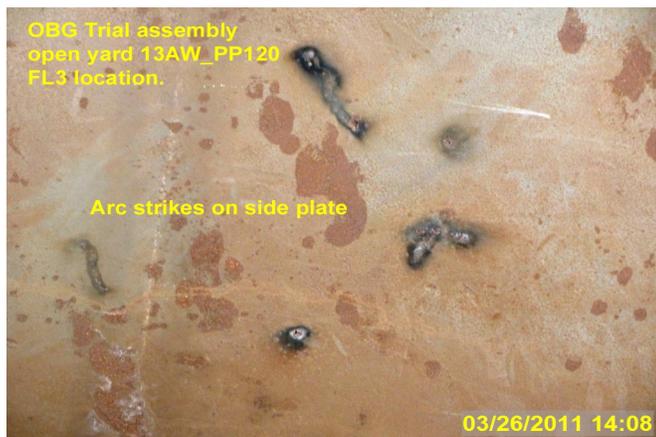
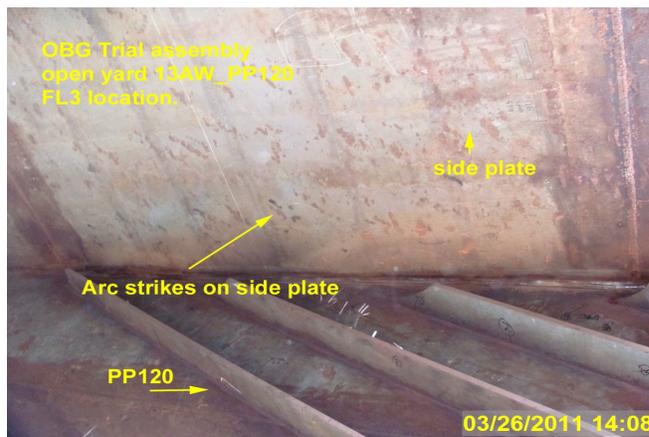
During random in process inspection of OBG Segment 13AW at Panel Point 120 at FL3 area, this QA observed an arc strikes on side plate. This QA marked the affected area and informed ZPMC QC identified as Mr. Zhang Qiang of this issue. Mr. Zhang Qiang informed this QA that the arc strikes would be corrected in a manner compliant with the contract documents. See attached photos for further information.
