Contract #: 04-0120F4Cty: SF/ALA Rte: 80 PM: 13.2/13.9File #: 69.28**WELDING INSPECTION REPORT****Resident Engineer:** Siegenthaler, Peter**Address:** 333 Burma Road**City:** Oakland, CA 94607**Report No:** WIR-022143**Date Inspected:** 27-Mar-2011**Project Name:** SAS Superstructure**OSM Arrival Time:** 700**Prime Contractor:** American Bridge/Fluor Enterprises, a JV**OSM Departure Time:** 1900**Contractor:** Zhenhua Port Machinery Company, Ltd (ZPMC), Changxing Island **Location:** Shanghai, China**CWI Name:** Liu Hua Jie.**CWI Present:** Yes No**Inspected CWI report:** Yes No N/A**Rod Oven in Use:** Yes No N/A**Electrode to specification:** Yes No N/A**Weld Procedures Followed:** Yes No N/A**Qualified Welders:** Yes No N/A**Verified Joint Fit-up:** Yes No N/A**Approved Drawings:** Yes No N/A**Approved WPS:** Yes No N/A**Delayed / Cancelled:** Yes No N/A**Bridge No:** 34-0006**Component:** OBG components.**Summary of Items Observed:**

Trial Assembly:

OBG Seg 13AE:

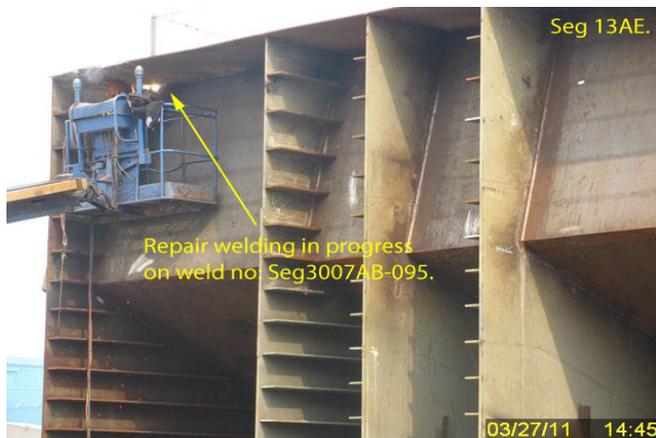
Repair welding of weld joint no: Seg3007AB-095 [Deck Panel (DP) 3072C to Edge Panel (EP) 3013C, complete joint penetration (CJP) weld]. The welder is identified as 037743 and was observed welding in the 4G position. Welding process was identified as Shielded Metal Arc Welding (SMAW). ZPMC Quality Control (QC) was identified as Liu Hua Jie. The welding variables recorded by this QC appeared to comply with WPS: 345-SMAW-4G(4F)-FCM-Repair. Repair welding was done as per Welding Repair Report (WRR): 20486 Rev-0. See attached photo for further information.
