DEPARTMENT OF TRANSPORTATION

Contract #: 04-0120F4Cty: SF/ALA Rte: 80 PM: 13.2/13.9File #: 69.28**WELDING INSPECTION REPORT****Resident Engineer:** Siegenthaler, Peter**Address:** 333 Burma Road**City:** Oakland, CA 94607**Report No:** WIR-022245**Date Inspected:** 21-Mar-2011**Project Name:** SAS Superstructure**OSM Arrival Time:** 1900**Prime Contractor:** American Bridge/Fluor Enterprises, a JV**OSM Departure Time:** 700**Contractor:** Zhenhua Port Machinery Company, Ltd (ZPMC), Changxing Island **Location:** Shanghai China**CWI Name:** See below**CWI Present:** Yes No**Inspected CWI report:** Yes No N/A**Rod Oven in Use:** Yes No N/A**Electrode to specification:** Yes No N/A**Weld Procedures Followed:** Yes No N/A**Qualified Welders:** Yes No N/A**Verified Joint Fit-up:** Yes No N/A**Approved Drawings:** Yes No N/A**Approved WPS:** Yes No N/A**Delayed / Cancelled:** Yes No N/A**Bridge No:** 34-0006**Component:** OBG**Summary of Items Observed:**

WELDING INSPECTION REPORT

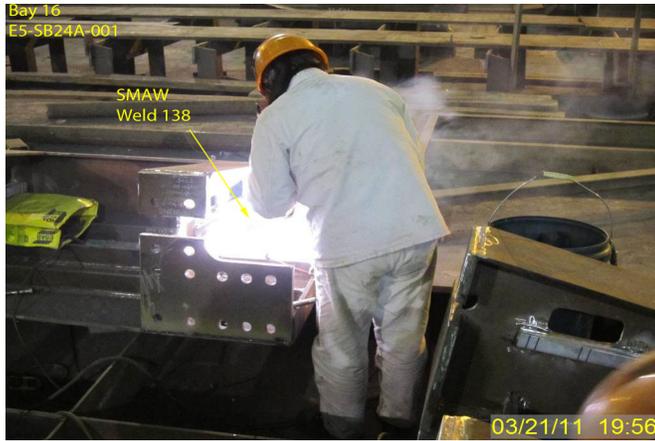
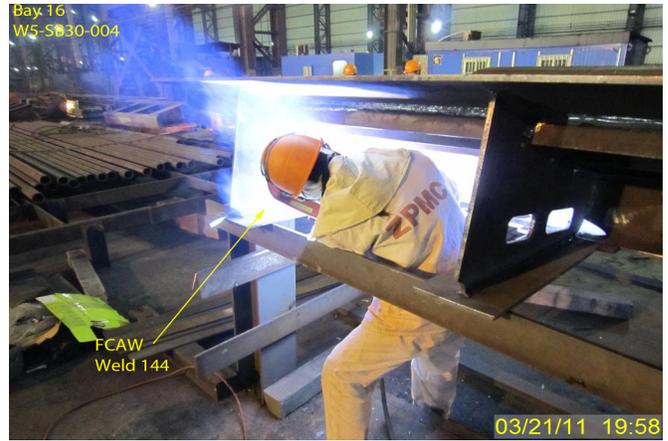
Unless otherwise noted, all work observed on this date appeared to be in general compliance with the applicable contract documents.
