Contract #: 04-0120F4Cty: SF/ALA Rte: 80 PM: 13.2/13.9File #: 69.28**WELDING INSPECTION REPORT****Resident Engineer:** Siegenthaler, Peter**Address:** 333 Burma Road**City:** Oakland, CA 94607**Report No:** WIR-022253**Date Inspected:** 28-Mar-2011**Project Name:** SAS Superstructure**OSM Arrival Time:** 700**Prime Contractor:** American Bridge/Fluor Enterprises, a JV**OSM Departure Time:** 1900**Contractor:** Zhenhua Port Machinery Company, Ltd (ZPMC), Changxing Island **Location:** Shanghai, China

Bridge No: 34-0006**Component:** Orthotropic Box Girder (OBG)**Summary of Items Observed:**

OBG Trial Assembly open yard.

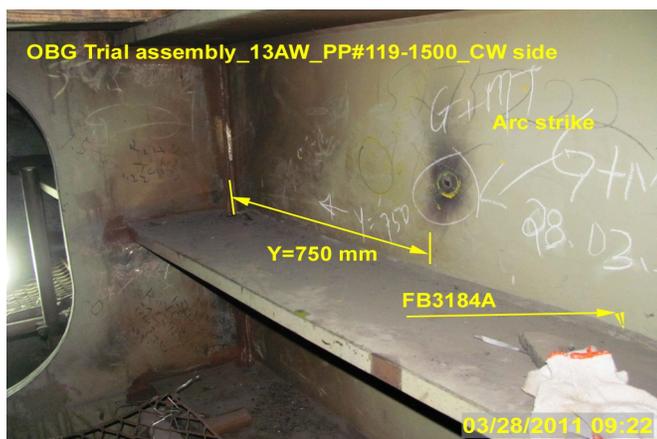
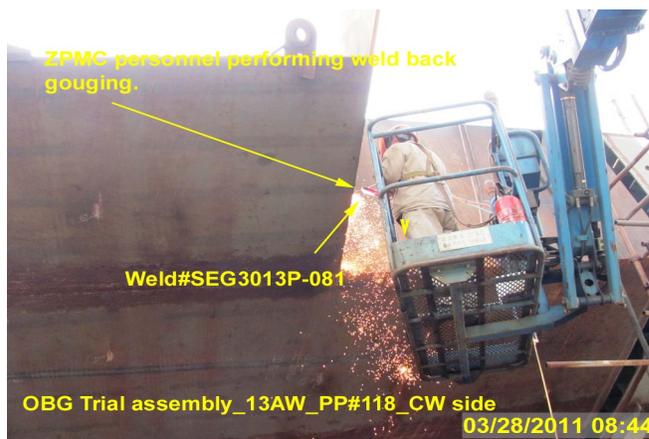
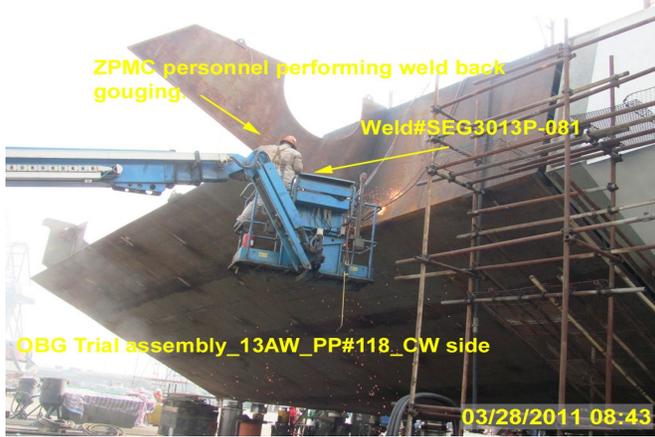
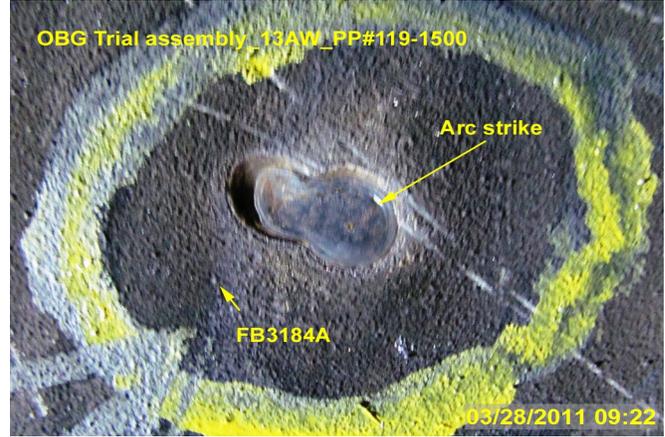
ZPMC personnel performing air-carbon arc gouging on weld joint identified as SEG3013P-081 at Panel point no. 118 counter weight side. See attached photos for further details.

During random in process inspection of OBG Segment 13AW at Panel Point 119-1500 on floor beam identified as FB3184A, this QA observed an arc strike. This QA marked the affected area and informed ZPMC QC identified as Mr. Zhang Qiang and AB/F QA Inspector identified as Mr. Kasi wang of this issue. Mr. Zhang Qiang and Mr. Kasi wang informed this QA that the arc strike would be corrected in a manner compliant with the contract documents. See attached photos for further information.
