Contract #: 04-0120F4Cty: SF/ALA Rte: 80 PM: 13.2/13.9File #: 69.28**WELDING INSPECTION REPORT****Resident Engineer:** Siegenthaler, Peter**Address:** 333 Burma Road**City:** Oakland, CA 94607**Report No:** WIR-022274**Date Inspected:** 03-Apr-2011**Project Name:** SAS Superstructure**OSM Arrival Time:** 700**Prime Contractor:** American Bridge/Fluor Enterprises, a JV**OSM Departure Time:** 1900**Contractor:** Zhenhua Port Machinery Company, Ltd (ZPMC), Changxing Island **Location:** Shanghai, China**CWI Name:** An Qing Xiang**CWI Present:** Yes No**Inspected CWI report:** Yes No N/A**Rod Oven in Use:** Yes No N/A**Electrode to specification:** Yes No N/A**Weld Procedures Followed:** Yes No N/A**Qualified Welders:** Yes No N/A**Verified Joint Fit-up:** Yes No N/A**Approved Drawings:** Yes No N/A**Approved WPS:** Yes No N/A**Delayed / Cancelled:** Yes No N/A**Bridge No:** 34-0006**Component:** OBG**Summary of Items Observed:**

## WELDING INSPECTION REPORT

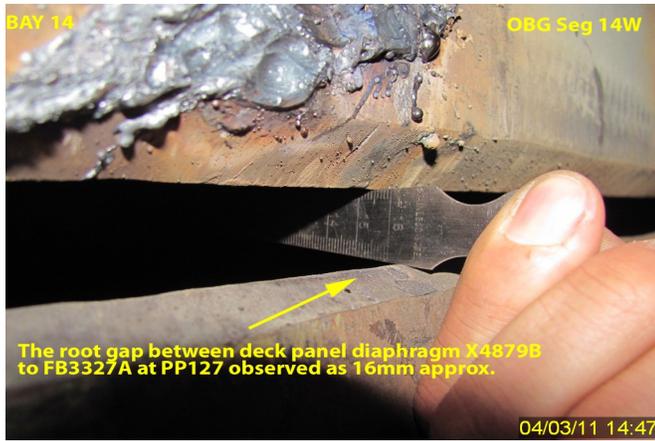
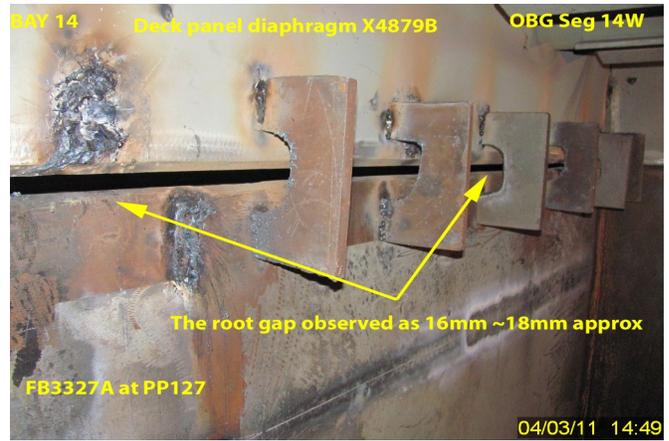
During random in process inspection this QA inspector observed that ZPMC personnel performing fit up of deck panel diaphragm plate X4879B of deck panel DP3172A/DP3173A to Floor Beam (FB) 3327A at PP127. During inspection the root gap observed as approx 16mm~18mm. This issue has been discussed with ZPMC CWI Mr. An Qing Xiang and CT Lead QA. Mr. An Qing Xiang informed this QA that ZPMC will use steel backing for this weld joint and provide necessary documents prior to start welding. Attached photograph provide additional details.
