**DEPARTMENT OF TRANSPORTATION**

Contract #: 04-0120F4Cty: SF/ALA Rte: 80 PM: 13.2/13.9File #: 69.28**WELDING INSPECTION REPORT****Resident Engineer:** Siegenthaler, Peter**Address:** 333 Burma Road**City:** Oakland, CA 94607**Report No:** WIR-022299**Date Inspected:** 17-Mar-2011**Project Name:** SAS Superstructure**OSM Arrival Time:** 700**Prime Contractor:** American Bridge/Fluor Enterprises, a JV**OSM Departure Time:** 1900**Contractor:** Zhenhua Port Machinery Company, Ltd (ZPMC), Changxing Island **Location:** Shanghai, China**CWI Name:** Xu Le Feng**CWI Present:** Yes No**Inspected CWI report:** Yes No N/A**Rod Oven in Use:** Yes No N/A**Electrode to specification:** Yes No N/A**Weld Procedures Followed:** Yes No N/A**Qualified Welders:** Yes No N/A**Verified Joint Fit-up:** Yes No N/A**Approved Drawings:** Yes No N/A**Approved WPS:** Yes No N/A**Delayed / Cancelled:** Yes No N/A**Bridge No:** 34-0006**Component:** OBG Components**Summary of Items Observed:**

## WELDING INSPECTION REPORT

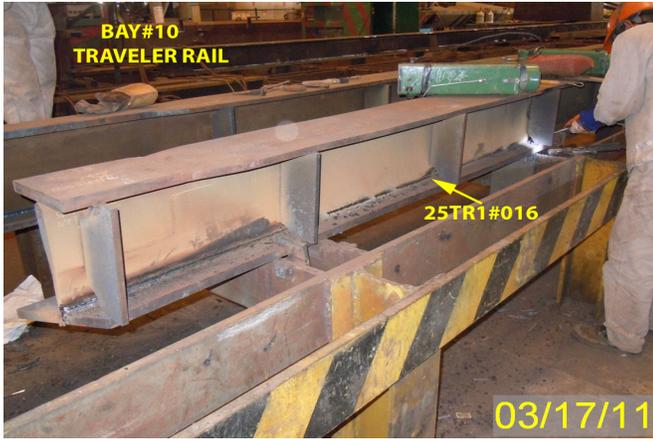
Weld joint #016 located on Traveler Rail 25TR1. Welder is identified as 057220. ZPMC Quality Control (QC) Inspector is identified as Jiang Xiao Bo. The welding variables recorded by QC appeared to comply with the WPS-B-P-2212-Tc-U5b. (See attached photo)

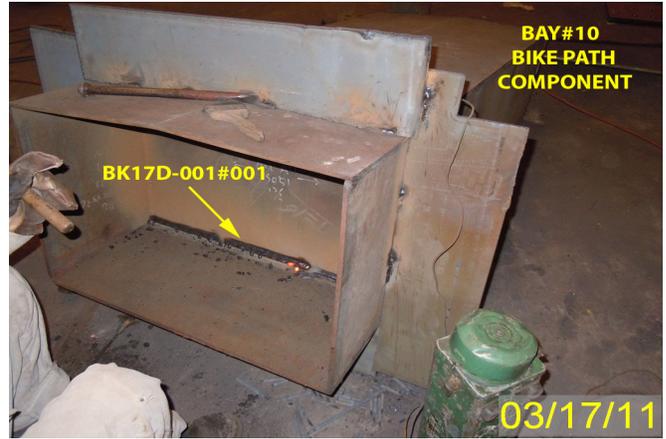
Weld joint #001 located on Bike path BK17D-001. Welder is identified as 040582. ZPMC Quality Control (QC) Inspector is identified as Sun Zi Wang. The welding variables recorded by QC appeared to comply with the WPS-B-P-2112-Tc-U4c. (See attached photo)
