DEPARTMENT OF TRANSPORTATION

Quality Assurance and Source Inspection

Contract #: 04-0120F4Cty: SF/Ala Rte: 80 PM: 13.2/13.9File #: 69.28**WELDING INSPECTION REPORT****Resident Engineer:** Siegenthaler, Peter**Address:** 333 Burma Road**City:** Oakland, CA 94607**Report No:** WIR-022350**Date Inspected:** 28-Mar-2011**Project Name:** SAS Superstructure**OSM Arrival Time:** 1900**Prime Contractor:** American Bridge/Fluor Enterprises, a JV**OSM Departure Time:** 700**Contractor:** Zhenhua Port Machinery Company, Ltd (ZPMC), Changxing Island **Location:** Shanghai, China**CWI Name:** See below**CWI Present:** Yes No**Inspected CWI report:** Yes No N/A**Rod Oven in Use:** Yes No N/A**Electrode to specification:** Yes No N/A**Weld Procedures Followed:** Yes No N/A**Qualified Welders:** Yes No N/A**Verified Joint Fit-up:** Yes No N/A**Approved Drawings:** Yes No N/A**Approved WPS:** Yes No N/A**Delayed / Cancelled:** Yes No N/A**Bridge No:** 34-0006**Component:** OBG Components**Summary of Items Observed:**

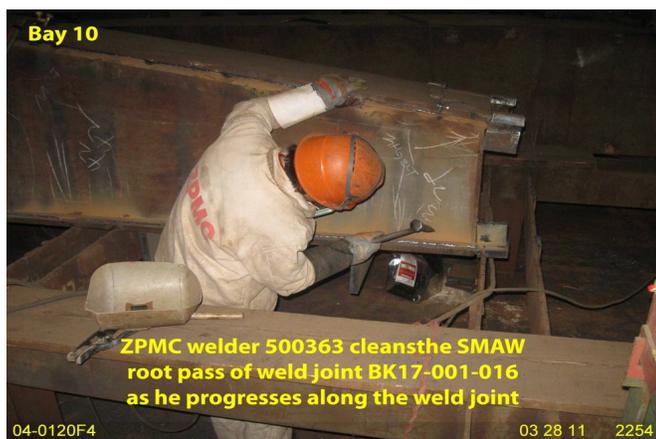
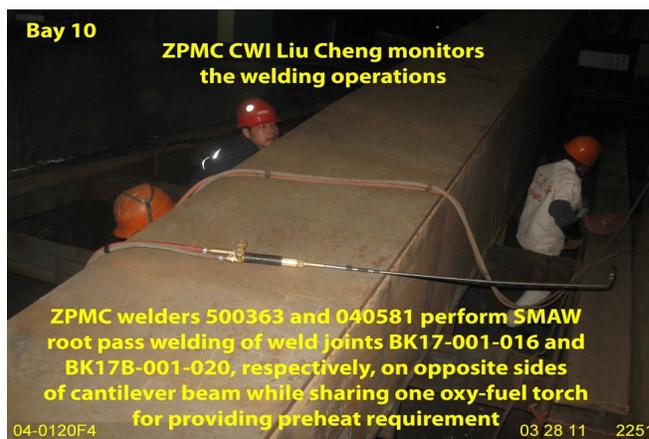
SMAW welding of the root pass of weld joint BK17B-001-020 located on PCMK OBG bike path cantilever beam. Welder was identified as 040581. QC was identified as ABF CWI Liu Cheng (QC1). Assisting QC1 at this location and appearing to be monitoring the welding operation and recording data was ZPMC QC Zhu Peng (QCA1), who was not a CWI. Weld variables recorded by QCA1 appeared to comply with WPS-B-P-2212-TC-U4c as verbally identified by QCA1.

SMAW welding of the root pass of weld joint BK17-001-016 located on PCMK OBG bike path cantilever beam. Welder was identified as 500363. QC was identified as QC1. Assisting QC1 at this location and appearing to be monitoring the welding operation and recording data was QCA1, who was not a CWI. Weld variables recorded by QCA1 appeared to comply with WPS-B-P-2212-TC-U4c as verbally identified by QCA1. This QA Inspector was unable to verify the root opening size of weld joints BK17-001-016 and BK17B-001-020 because they were almost complete at the time of observance. See photos below of the welding operations in progress.
