DEPARTMENT OF TRANSPORTATION

Quality Assurance and Source Inspection

Contract #: 04-0120F4Cty: SF/ALA Rte: 80 PM: 13.2/13.9File #: 82.28**WELDING INSPECTION REPORT****Resident Engineer:** Siegenthaler, Peter**Address:** 333 Burma Road**City:** Oakland, CA 94607**Report No:** WIR-022376**Date Inspected:** 15-Mar-2011**Project Name:** SAS Superstructure**OSM Arrival Time:** 700**Prime Contractor:** American Bridge/Fluor Enterprises, a JV**OSM Departure Time:** 1530**Contractor:** Westmont Industries**Location:** Santa Fe Springs, CA.**CWI Name:** Ruben Dominguez**CWI Present:** Yes No**Inspected CWI report:** Yes No N/A**Rod Oven in Use:** Yes No N/A**Electrode to specification:** Yes No N/A**Weld Procedures Followed:** Yes No N/A**Qualified Welders:** Yes No N/A**Verified Joint Fit-up:** Yes No N/A**Approved Drawings:** Yes No N/A**Approved WPS:** Yes No N/A**Delayed / Cancelled:** Yes No N/A**Bridge No:** 34-0006**Component:** Travelers**Summary of Items Observed:**

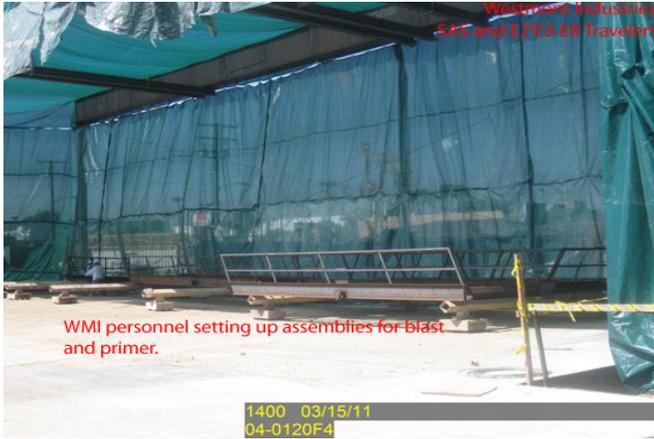
After conversation, this QA Inspector and Mr. Shanley then met with Westmont Industries (WMI) representative Mr. Brad Petrie and RPI Coating representatives, Mr. Carlos Torres and Mr. Gary McDonald. During conversation, WMI and RPI representatives appeared to understand the contract requirements, for painting of the Travelers and Traveler assemblies. Mr. Torres explained that RPI will continue to set up equipment for blast and painting purposes and blast will probably start tomorrow. Near the end of the shift, this QA Inspector observed that WMI personnel had placed what appeared to be Traveler assemblies, on stands in a previously tarp inclosed area, as shown in attached picture.
