Contract #: 04-0120F4Cty: SF/ALA Rte: 80 PM: 13.2/13.9File #: 69.28**WELDING INSPECTION REPORT****Resident Engineer:** Siegenthaler, Peter**Address:** 333 Burma Road**City:** Oakland, CA 94607**Report No:** WIR-022391**Date Inspected:** 30-Mar-2011**Project Name:** SAS Superstructure**OSM Arrival Time:** 700**Prime Contractor:** American Bridge/Fluor Enterprises, a JV**OSM Departure Time:** 1900**Contractor:** Zhenhua Port Machinery Company, Ltd (ZPMC), Changxing Island **Location:** Shanghai, China**CWI Name:** An Qing Xiang**CWI Present:** Yes No**Inspected CWI report:** Yes No N/A**Rod Oven in Use:** Yes No N/A**Electrode to specification:** Yes No N/A**Weld Procedures Followed:** Yes No N/A**Qualified Welders:** Yes No N/A**Verified Joint Fit-up:** Yes No N/A**Approved Drawings:** Yes No N/A**Approved WPS:** Yes No N/A**Delayed / Cancelled:** Yes No N/A**Bridge No:** 34-0006**Component:** OBG**Summary of Items Observed:**

BAY 14, OBG 13BW (NWIT # 08673)

WELDING INSPECTION REPORT

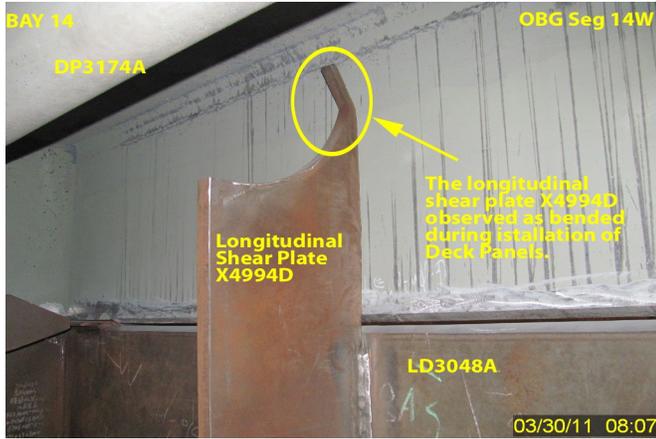
During random in process visual inspection this QA Inspector observed that longitudinal shear plate X4994D on Longitudinal Diaphragm (LD) 3048A in between PP127.5 to PP128 was bent at the top for a length of approx. 200mm during installation of deck panels of segment 14W. This issue was discussed with ZPMC CWI Mr. An Qing Xiang and CT Lead QA Inspector. Mr. An Qing Xiang informed this QA that this issue would be resolved compliant to the contract documents. Attached photograph provide additional details.
