Quality Assurance and Source Inspection

Contract #: 04-0120F4Cty: SF/ALA Rte: 80 PM: 13.2/13.9File #: 69.28**WELDING INSPECTION REPORT****Resident Engineer:** Siegenthaler, Peter**Address:** 333 Burma Road**City:** Oakland, CA 94607**Report No:** WIR-022462**Date Inspected:** 24-Dec-2010**Project Name:** SAS Superstructure**OSM Arrival Time:** 700**Prime Contractor:** American Bridge/Fluor Enterprises, a JV**OSM Departure Time:** 1900**Contractor:** Zhenhua Port Machinery Company, Ltd (ZPMC), Changxing Island **Location:** Shanghai, China**CWI Name:** Qiu Wen**CWI Present:** Yes No**Inspected CWI report:** Yes No N/A**Rod Oven in Use:** Yes No N/A**Electrode to specification:** Yes No N/A**Weld Procedures Followed:** Yes No N/A**Qualified Welders:** Yes No N/A**Verified Joint Fit-up:** Yes No N/A**Approved Drawings:** Yes No N/A**Approved WPS:** Yes No N/A**Delayed / Cancelled:** Yes No N/A**Bridge No:** 34-0006**Component:** OBG**Summary of Items Observed:**

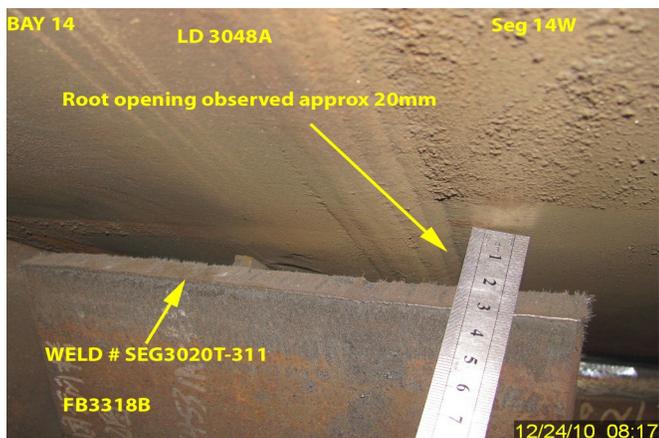
During random in process inspection this QA inspector observed the fit up for weld number, SEG3020T-311[Floor Beam (FB) 3318B to Longitudinal Diaphragm (LD) 3048A, CJP weld at panel point (PP) 125.5]. The fit up was done with root gap approx 20mm. This issue has been discussed with ZPMC lead QC Mr. Li Ming Yang. Mr Li Ming Yang informed this QA that ZPMC will make welding repair report (WRR) for buttering on the edge to reduce the root gap within acceptable limit and perform the repair work. Attached photograph provide additional detail.
