DEPARTMENT OF TRANSPORTATION

Quality Assurance and Source Inspection

Contract #: 04-0120F4Cty: SF/ALA Rte: 80 PM: 13.2/13.9File #: 69.28**WELDING INSPECTION REPORT****Resident Engineer:** Siegenthaler, Peter**Address:** 333 Burma Road**City:** Oakland, CA 94607**Report No:** WIR-022507**Date Inspected:** 08-Apr-2011**Project Name:** SAS Superstructure**OSM Arrival Time:** 700**Prime Contractor:** American Bridge/Fluor Enterprises, a JV**OSM Departure Time:** 1900**Contractor:** Zhenhua Port Machinery Company, Ltd (ZPMC), Changxing Island **Location:** Shanghai, China**CWI Name:** Liu Hua Jie.**CWI Present:** Yes No**Inspected CWI report:** Yes No N/A**Rod Oven in Use:** Yes No N/A**Electrode to specification:** Yes No N/A**Weld Procedures Followed:** Yes No N/A**Qualified Welders:** Yes No N/A**Verified Joint Fit-up:** Yes No N/A**Approved Drawings:** Yes No N/A**Approved WPS:** Yes No N/A**Delayed / Cancelled:** Yes No N/A**Bridge No:** 34-0006**Component:** OBG components.**Summary of Items Observed:**

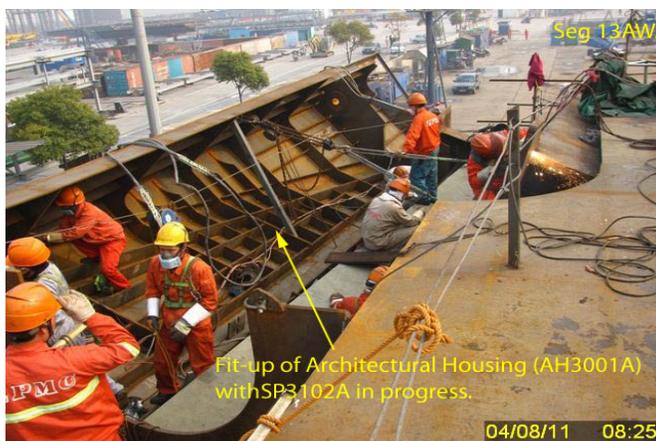
ZPMC personnel performing fit-up of Architectural Housing (AH) 3001A with Side Panel (SP) 3102A. See attached photo for further details.
