Contract #: 04-0120F4Cty: SF/ALA Rte: 80 PM: 13.2/13.9File #: 69.28**WELDING INSPECTION REPORT****Resident Engineer:** Siegenthaler, Peter**Address:** 333 Burma Road**City:** Oakland, CA 94607**Report No:** WIR-022519**Date Inspected:** 13-Apr-2011**Project Name:** SAS Superstructure**OSM Arrival Time:** 700**Prime Contractor:** American Bridge/Fluor Enterprises, a JV**OSM Departure Time:** 1900**Contractor:** Zhenhua Port Machinery Company, Ltd (ZPMC), Changxing Island **Location:** Shanghai, China**CWI Name:** Mr. Liu hua jie**CWI Present:** Yes No**Inspected CWI report:** Yes No N/A**Rod Oven in Use:** Yes No N/A**Electrode to specification:** Yes No N/A**Weld Procedures Followed:** Yes No N/A**Qualified Welders:** Yes No N/A**Verified Joint Fit-up:** Yes No N/A**Approved Drawings:** Yes No N/A**Approved WPS:** Yes No N/A**Delayed / Cancelled:** Yes No N/A**Bridge No:** 34-0006**Component:** Orthotropic Box Girder (OBG)**Summary of Items Observed:**

OBG Trial Assembly open yard.

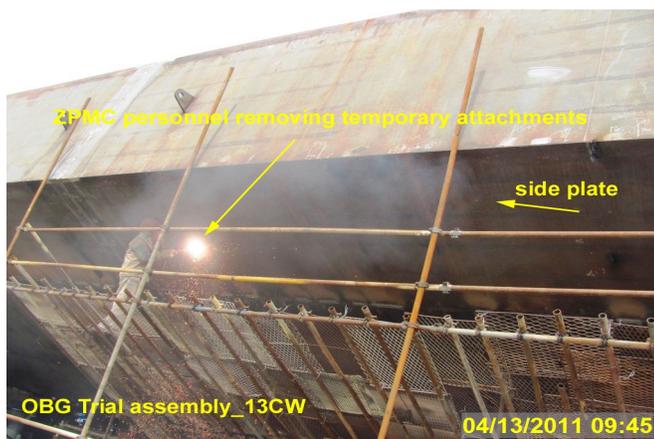
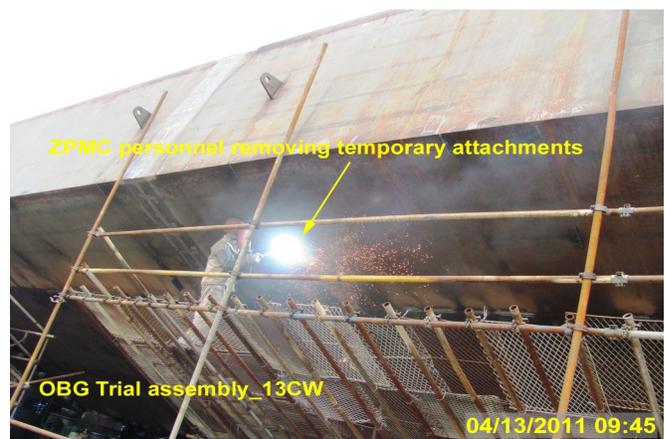
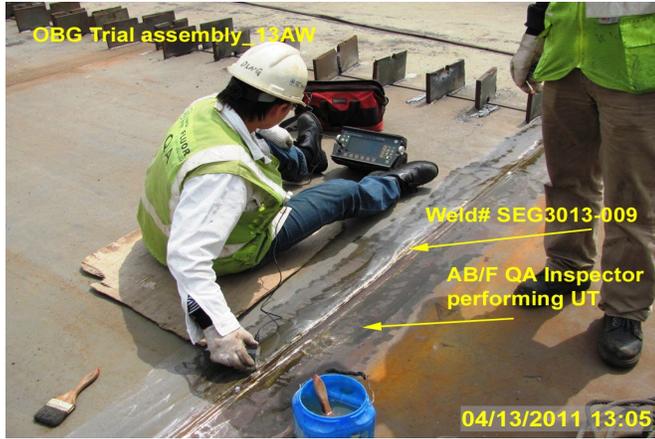
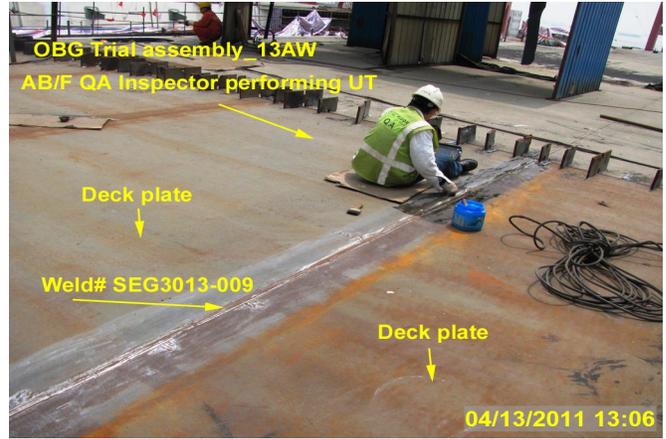
AB/F QA Inspector performing UT for the splice weld joint identified as SEG3013-009 on deck panel. See attached photos for further information.

ZPMC personnel removing temporary attachments on side plate by air-carbon arc gouging at cross beam side. See attached photos for further information.
