**DEPARTMENT OF TRANSPORTATION**

Contract #: 04-0120F4Cty: SF/ALA Rte: 80 PM: 13.2/13.9File #: 1.28**WELDING INSPECTION REPORT****Resident Engineer:** Siegenthaler, Peter**Address:** 333 Burma Road**City:** Oakland, CA 94607**Report No:** WIR-022538**Date Inspected:** 14-Apr-2011**Project Name:** SAS Superstructure**OSM Arrival Time:** 700**Prime Contractor:** American Bridge/Fluor Enterprises, a JV**OSM Departure Time:** 1530**Contractor:** American Bridge/Fluor Enterprises, a JV**Location:** Jobsite**CWI Name:** Gary Ehram**CWI Present:** Yes No**Inspected CWI report:** Yes No N/A**Rod Oven in Use:** Yes No N/A**Electrode to specification:** Yes No N/A**Weld Procedures Followed:** Yes No N/A**Qualified Welders:** Yes No N/A**Verified Joint Fit-up:** Yes No N/A**Approved Drawings:** Yes No N/A**Approved WPS:** Yes No N/A**Delayed / Cancelled:** Yes No N/A**Bridge No:** 34-0006**Component:** SAS OBG**Summary of Items Observed:**

# WELDING INSPECTION REPORT

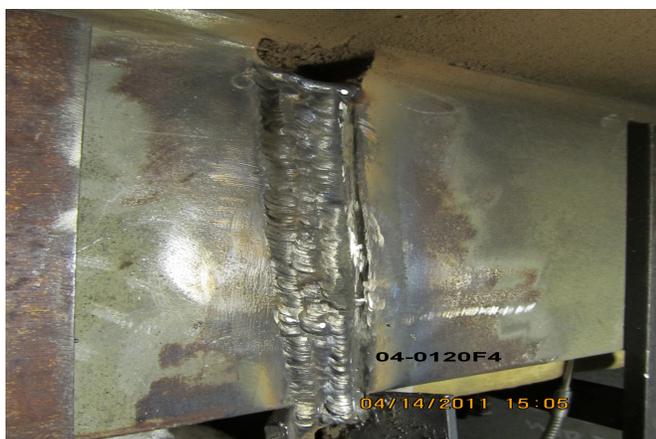
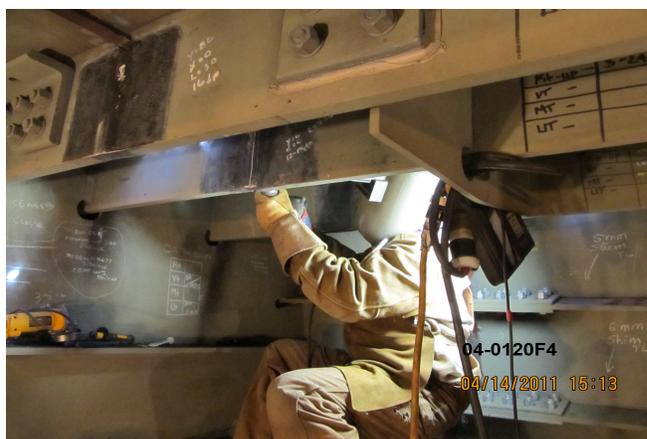
The QA Inspector observed the QC inspector perform Magnetic Particle Testing on the back gouge of face A. It was noted by the QA Inspector that several indications appeared to be identified. The QA Inspector periodically observed the ABF welder Kit Kitlai repair by grinding the area previously mentioned above to conform to the contract documents. It was noted by the QA Inspector that the welder did not complete the repair by the end of the QA Inspectors shift.

The QA Inspector randomly observed the ABF welder Jin Pei Wang to be utilizing (SMAW) manually for the above identified weld joint. The QA Inspector randomly observed the welding. The QA Inspector observed the QC Inspector identified as Gary Ehram periodically monitor the welding parameters as specified by the approved WPS ABF-WPS-D1.5-1012-3. It was noted by the QA Inspector that the welder had not completed the weld by the end of the QA Inspectors shift.
