Quality Assurance and Source Inspection

Contract #: 04-0120F4Cty: SF/ALA Rte: 80 PM: 13.2/13.9File #: 1.28**WELDING INSPECTION REPORT****Resident Engineer:** Siegenthaler, Peter**Address:** 333 Burma Road**City:** Oakland, CA 94607**Report No:** WIR-022540**Date Inspected:** 14-Apr-2011**Project Name:** SAS Superstructure**OSM Arrival Time:** 700**Prime Contractor:** American Bridge/Fluor Enterprises, a JV**OSM Departure Time:** 1530**Contractor:** American Bridge/Fluor Enterprises, a JV**Location:** Job Site**CWI Name:** See Report Below**CWI Present:** Yes No**Inspected CWI report:** Yes No N/A**Rod Oven in Use:** Yes No N/A**Electrode to specification:** Yes No N/A**Weld Procedures Followed:** Yes No N/A**Qualified Welders:** Yes No N/A**Verified Joint Fit-up:** Yes No N/A**Approved Drawings:** Yes No N/A**Approved WPS:** Yes No N/A**Delayed / Cancelled:** Yes No N/A**Bridge No:** 34-0006**Component:** Orthotropic Box Girders**Summary of Items Observed:**

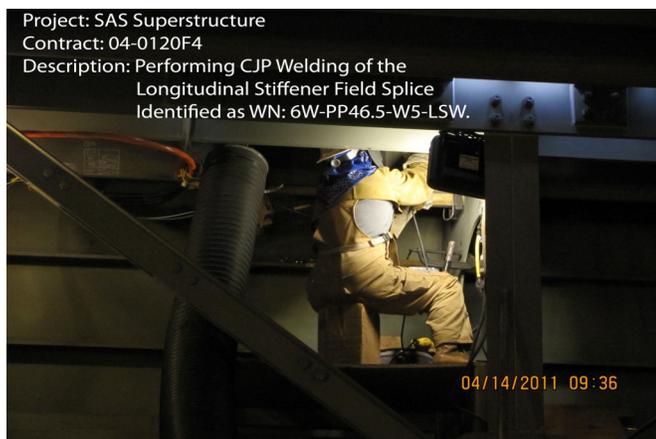
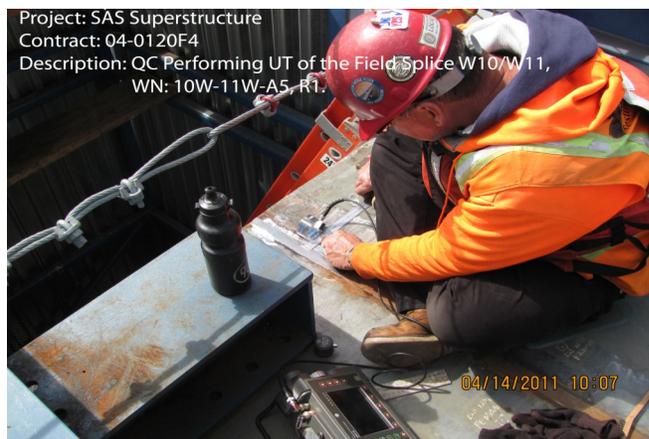
The QAI also observed the CJP welding of the longitudinal stiffener located at the deck access hole identified as WN: 6W-PP46.5-W5-LSW. The welding was performed by Xiao Jian Wan ID-9677 utilizing the WPS identified as ABF-WPS-D15-1012-3, Rev. 0. The welding parameters were verified by the QC inspector Gary Ehram and appeared to comply with the contract specifications. The CJP welding was not completed during this shift.

The QAI also observed the excavation of the UT reject of the longitudinal stiffener located at the field splice W7/W8 identified as WN: 7W-8W-A-LS5, repair cycle R1. The excavation was performed by the welder Wai Kitai ID-2953 and the Magnetic Particle Testing (MPT) of the back gouge was performed by Gary Ehram. The

dimensions were observed and verified by the QAI and were noted as follows; Y=0 mm, L=230 mm, d=15 mm. No welding was performed during this shift.

The digital photographs below illustrate some of the work observed during this scheduled shift.
