**DEPARTMENT OF TRANSPORTATION**

Contract #: 04-0120F4Cty: SF/ALA Rte: 80 PM: 13.2/13.9File #: 99.28**WELDING INSPECTION REPORT****Resident Engineer:** Siegenthaler, Peter**Address:** 333 Burma Road**City:** Oakland, CA 94607**Report No:** WIR-022549**Date Inspected:** 04-Nov-2010**Project Name:** SAS Superstructure**OSM Arrival Time:** 700**Prime Contractor:** American Bridge/Fluor Enterprises, a JV**OSM Departure Time:** 1900**Contractor:** Zhenhua Port Machinery Company, Ltd (ZPMC) Chanxing Island **Location:** Shanghai, China**CWI Name:** Mr. LIU HUA JIE**CWI Present:** Yes No**Inspected CWI report:** Yes No N/A**Rod Oven in Use:** Yes No N/A**Electrode to specification:** Yes No N/A**Weld Procedures Followed:** Yes No N/A**Qualified Welders:** Yes No N/A**Verified Joint Fit-up:** Yes No N/A**Approved Drawings:** Yes No N/A**Approved WPS:** Yes No N/A**Delayed / Cancelled:** Yes No N/A**Bridge No:** 34-0006**Component:** OBG Segment**Summary of Items Observed:**

Orthotropic Box Girder (OBG) at Trial Assembly Area:

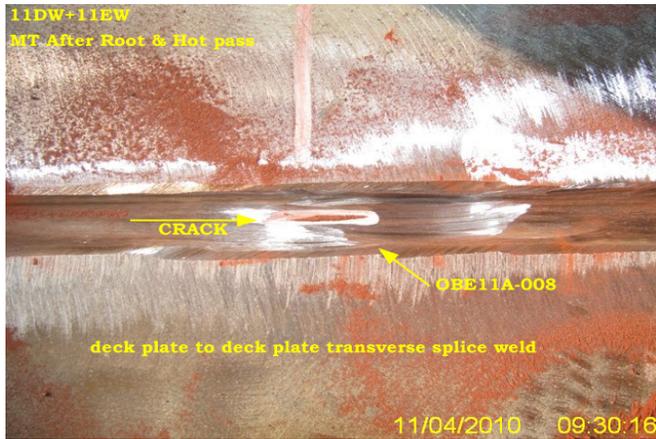
ABF Quality Control (QC) personnel performing Magnetic particle Testing (MT) for the after completed root and hot pass of deck plate to deck plate transverse splice weld joint located on 11DW+11EW. The weld is designated as OBW11A-008. ABF QC found longitudinal linear crack in the weld. The above information passed over ZPMC QC Mr. ZHU ZHONG HAI for further ratification. See attached picture for details.
