DEPARTMENT OF TRANSPORTATION

Quality Assurance and Source Inspection

Contract #: 04-0120F4Cty: SF/ALA Rte: 80 PM: 13.2/13.9File #: 99.28**WELDING INSPECTION REPORT****Resident Engineer:** Siegenthaler, Peter**Address:** 333 Burma Road**City:** Oakland, CA 94607**Report No:** WIR-022554**Date Inspected:** 04-Apr-2011**Project Name:** SAS Superstructure**OSM Arrival Time:** 700**Prime Contractor:** American Bridge/Fluor Enterprises, a JV**OSM Departure Time:** 1900**Contractor:** Zhenhua Port Machinery Company, Ltd (ZPMC) Chanxing Island**Location:** Shanghai, China**CWI Name:** Mr. ZHU ZHONG HAI**CWI Present:** Yes No**Inspected CWI report:** Yes No N/A**Rod Oven in Use:** Yes No N/A**Electrode to specification:** Yes No N/A**Weld Procedures Followed:** Yes No N/A**Qualified Welders:** Yes No N/A**Verified Joint Fit-up:** Yes No N/A**Approved Drawings:** Yes No N/A**Approved WPS:** Yes No N/A**Delayed / Cancelled:** Yes No N/A**Bridge No:** 34-0006**Component:** OBG Segment**Summary of Items Observed:**

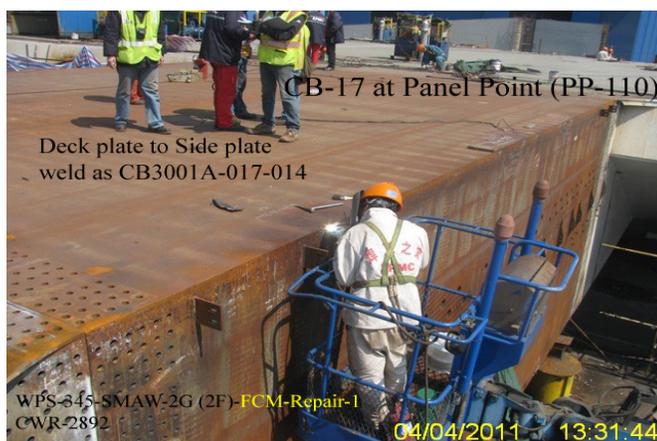
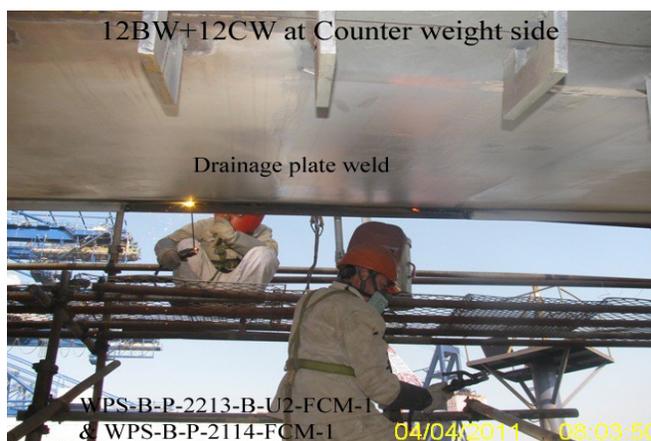
ZPMC welding personnel performing Shielded Metal Arc Welding of Repair weld for the deck plate to side plate weld joint located on CB-17 at Panel Point (PP-110). The weld is designated as CB3001A-017-014. The welder is identified as 066459. ZPMC QC Mr. LI YANG was onsite monitoring the welding variables. The inprocess Shielded Metal Arc Welding appears to be progressing in compliance with WPS-345-SMAW-2G (2F)-FCM-Repair-1. The weld repair report number is named as CWR-2892. Further weld detail mention in attached picture.

ZPMC welding personnel performing Shielded Metal Arc Welding of Complete Joint Penetration welds joining the drainage plate to drainage plate weld joint located on 12CW at counter weight side. The weld is designated as CA3012-233. The welder is identified as 057333. ZPMC QC Mr. ZHOU PENG was onsite monitoring the welding variables. The inprocess Shielded Metal Arc Welding appears to be progressing in compliance with WPS-B-P-2213-B-U2-FCM-1. Further weld detail mention in attached picture.

ZPMC welding personnel performing Shielded Metal Arc Welding of Fillet welds joining the drainage plate to edge plate weld joint located on 12BW+12CW at counter weight side. The weld is designated as CA3012-234 & 235. The welder is identified as 057333. ZPMC QC Mr. SHEN JIAN BO was onsite monitoring the welding variables. The inprocess Shielded Metal Arc Welding appears to be progressing in compliance with WPS-B-P-2114-FCM-1. Further weld detail mention in attached picture.

ZPMC welding personnel performing Shielded Metal Arc Welding of Complete Joint Penetration welds joining the drainage plate to drainage plate weld joint located on 12BW at counter weight side. The weld is designated as CA3012-232. The welder is identified as 046709. ZPMC QC Mr. ZHOU PENG was onsite monitoring the welding variables. The inprocess Shielded Metal Arc Welding appears to be progressing in compliance with WPS-B-P-2213-B-U2-FCM-1. Further weld detail mention in attached picture.
