DEPARTMENT OF TRANSPORTATION

Contract #: 04-0120F4Cty: SF/ALA Rte: 80 PM: 13.2/13.9File #: 99.28**WELDING INSPECTION REPORT****Resident Engineer:** Siegenthaler, Peter**Address:** 333 Burma Road**City:** Oakland, CA 94607**Report No:** WIR-022600**Date Inspected:** 09-Apr-2011**Project Name:** SAS Superstructure**OSM Arrival Time:** 700**Prime Contractor:** American Bridge/Fluor Enterprises, a JV**OSM Departure Time:** 1900**Contractor:** Zhenhua Port Machinery Company, Ltd (ZPMC) Chanxing Island**Location:** Shanghai, China**CWI Name:** Mr. An Qing Xing**CWI Present:** Yes No**Inspected CWI report:** Yes No N/A**Rod Oven in Use:** Yes No N/A**Electrode to specification:** Yes No N/A**Weld Procedures Followed:** Yes No N/A**Qualified Welders:** Yes No N/A**Verified Joint Fit-up:** Yes No N/A**Approved Drawings:** Yes No N/A**Approved WPS:** Yes No N/A**Delayed / Cancelled:** Yes No N/A**Bridge No:** 34-0006**Component:** OBG Segment**Summary of Items Observed:**

WELDING INSPECTION REPORT

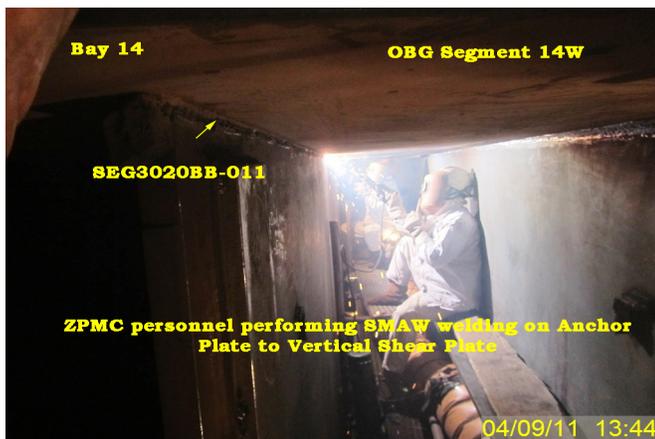
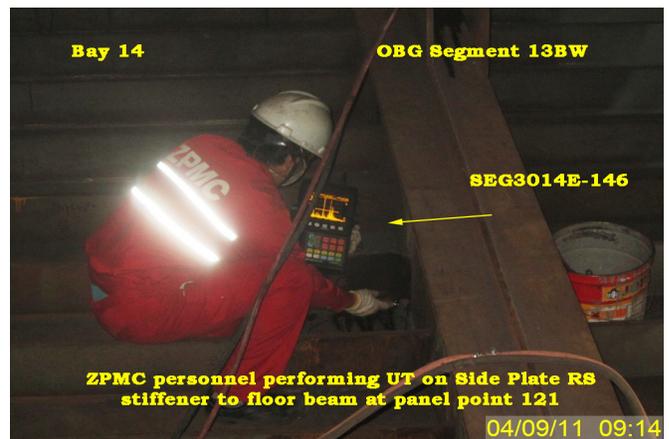
This QA inspector observed ZPMC personnel performed Ultrasonic Testing on Side Plate RS Stiffener to Floor Beam weld of OBG Segment 13BW. The weld numbers are identifies as SEG3014C-129, 130, SEG3014E-146, 147, SEG3014G-129, 130 and SEG3014J-129, 130. See the attached pictures.
