DEPARTMENT OF TRANSPORTATION

Quality Assurance and Source Inspection

Contract #: 04-0120F4Cty: SF/ALA Rte: 80 PM: 13.2/13.9File #: 69.28**WELDING INSPECTION REPORT****Resident Engineer:** Siegenthaler, Peter**Address:** 333 Burma Road**City:** Oakland, CA 94607**Report No:** WIR-022623**Date Inspected:** 15-Apr-2011**Project Name:** SAS Superstructure**OSM Arrival Time:** 700**Prime Contractor:** American Bridge/Fluor Enterprises, a JV**OSM Departure Time:** 1900**Contractor:** Zhenhua Port Machinery Company, Ltd (ZPMC), Changxing Island **Location:** Shanghai, China**CWI Name:** Liu Hua Jie**CWI Present:** Yes No**Inspected CWI report:** Yes No N/A**Rod Oven in Use:** Yes No N/A**Electrode to specification:** Yes No N/A**Weld Procedures Followed:** Yes No N/A**Qualified Welders:** Yes No N/A**Verified Joint Fit-up:** Yes No N/A**Approved Drawings:** Yes No N/A**Approved WPS:** Yes No N/A**Delayed / Cancelled:** Yes No N/A**Bridge No:** 34-0006**Component:** OBG**Summary of Items Observed:**

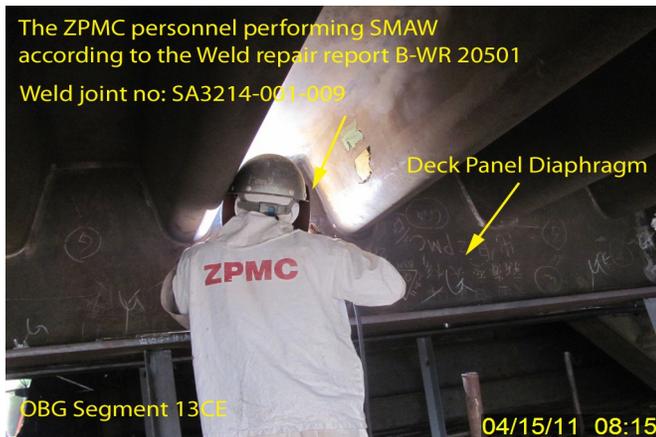
SMAW welding of weld joint No: SA3214-001-009 located on OBG Segment 13CE Deck panel Diaphragm. Welder is identified as #066258. ZPMC QC is identified as Mr. Wang Xu. Welding was performed with the weld repair report BWR-20501. The welding variables recorded by QC appeared to comply with the WPS-345-SMAW-3G(3F)-FCM-Repair-1. Please see the attached picture.
