**DEPARTMENT OF TRANSPORTATION**

Contract #: 04-0120F4Cty: SF/ALA Rte: 80 PM: 13.2/13.9File #: 69.28**WELDING INSPECTION REPORT****Resident Engineer:** Siegenthaler, Peter**Address:** 333 Burma Road**City:** Oakland, CA 94607**Report No:** WIR-022635**Date Inspected:** 30-Mar-2011**Project Name:** SAS Superstructure**OSM Arrival Time:** 700**Prime Contractor:** American Bridge/Fluor Enterprises, a JV**OSM Departure Time:** 1900**Contractor:** Zhenhua Port Machinery Company, Ltd (ZPMC), Changxing Island **Location:** Shanghai, China**CWI Name:** Geng Wei**CWI Present:** Yes No**Inspected CWI report:** Yes No N/A**Rod Oven in Use:** Yes No N/A**Electrode to specification:** Yes No N/A**Weld Procedures Followed:** Yes No N/A**Qualified Welders:** Yes No N/A**Verified Joint Fit-up:** Yes No N/A**Approved Drawings:** Yes No N/A**Approved WPS:** Yes No N/A**Delayed / Cancelled:** Yes No N/A**Bridge No:** 34-0006**Component:** OBG**Summary of Items Observed:**

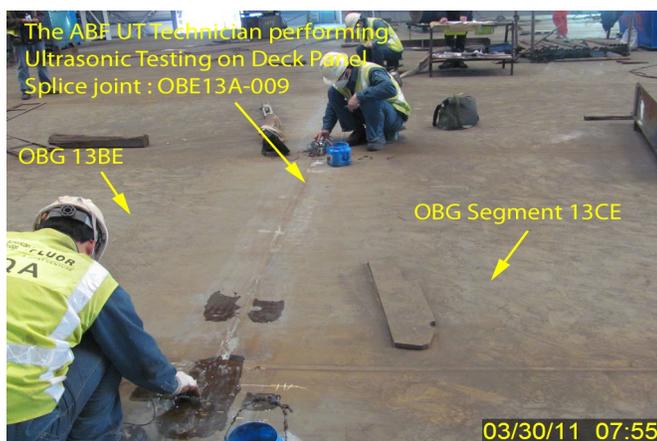
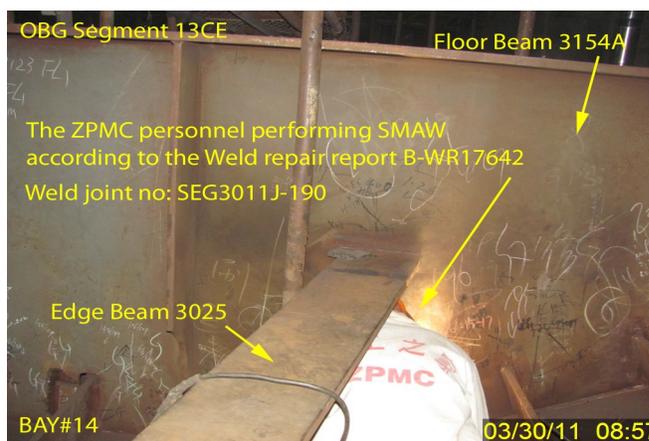
SMAW welding of weld joint No: SEG3011J-190 located on OBG Segment 13BE Side panel stiffener to Floor Beam. Welder is identified as #067656. ZPMC QC is identified as Mr. Wang Xu. Welding was performed with the weld repair report BWR-17642. The welding variables recorded by QC appeared to comply with the WPS-345-SMAW-3G(3F)-FCM-Repair-1. Please see the attached picture.
