DEPARTMENT OF TRANSPORTATION

Contract #: 04-0120F4Cty: SF/ALA Rte: 80 PM: 13.2/13.9File #: 69.28**WELDING INSPECTION REPORT****Resident Engineer:** Siegenthaler, Peter**Address:** 333 Burma Road**City:** Oakland, CA 94607**Report No:** WIR-022659**Date Inspected:** 16-Apr-2011**Project Name:** SAS Superstructure**OSM Arrival Time:** 700**Prime Contractor:** American Bridge/Fluor Enterprises, a JV**OSM Departure Time:** 1900**Contractor:** Zhenhua Port Machinery Company, Ltd (ZPMC), Changxing Island **Location:** Shanghai, China**CWI Name:** Mr. Liu hua jie**CWI Present:** Yes No**Inspected CWI report:** Yes No N/A**Rod Oven in Use:** Yes No N/A**Electrode to specification:** Yes No N/A**Weld Procedures Followed:** Yes No N/A**Qualified Welders:** Yes No N/A**Verified Joint Fit-up:** Yes No N/A**Approved Drawings:** Yes No N/A**Approved WPS:** Yes No N/A**Delayed / Cancelled:** Yes No N/A**Bridge No:** 34-0006**Component:** Orthotropic Box Girder (OBG)**Summary of Items Observed:**

OBG Trial Assembly open yard.

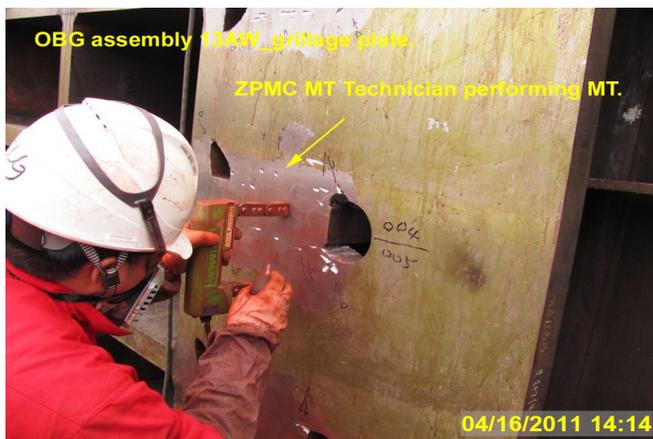
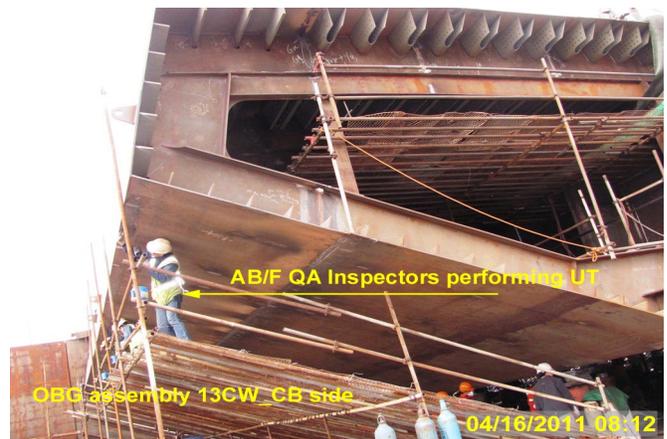
ZPMC MT Technician performing Magnetic Particle Testing (MT) for the grillage plate SA7512A Partial joint penetration repair welds longitudinal linear indications excavated areas. These welds previously rejected by ZPMC MT Technicians and recorded on MT report no.B787-MT-39184.The repair was being performing as per the CWR-B-CWR2927.See attached photos for further information.

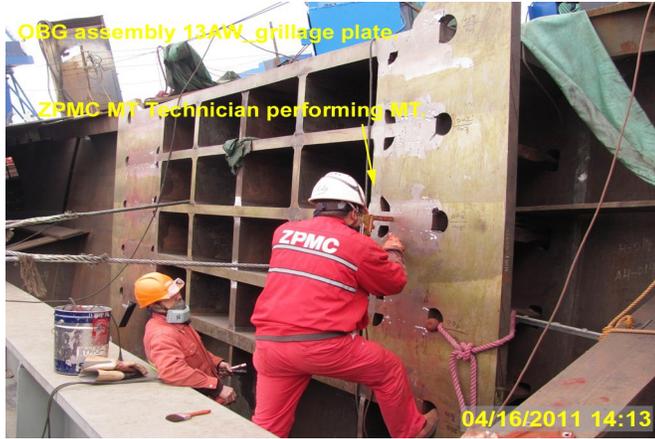
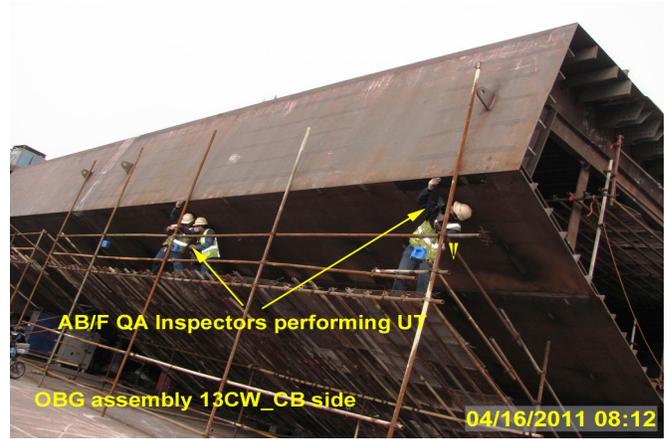
AB/F QA Inspectors performing UT for the side plate to edge plate weld joint at Cross beam side. See attached photos for further information.
