Contract #: 04-0120F4Cty: SF/ALA Rte: 80 PM: 13.2/13.9File #: 69.28**WELDING INSPECTION REPORT****Resident Engineer:** Siegenthaler, Peter**Address:** 333 Burma Road**City:** Oakland, CA 94607**Report No:** WIR-022678**Date Inspected:** 17-Apr-2011**Project Name:** SAS Superstructure**OSM Arrival Time:** 1500**Prime Contractor:** American Bridge/Fluor Enterprises, a JV**OSM Departure Time:** 300**Contractor:** Zhenhua Port Machinery Company, Ltd (ZPMC), Changxing Island **Location:** Shanghai, China**CWI Name:** Mr. Li Yang ZPMC**CWI Present:** Yes No**Inspected CWI report:** Yes No N/A**Rod Oven in Use:** Yes No N/A**Electrode to specification:** Yes No N/A**Weld Procedures Followed:** Yes No N/A**Qualified Welders:** Yes No N/A**Verified Joint Fit-up:** Yes No N/A**Approved Drawings:** Yes No N/A**Approved WPS:** Yes No N/A**Delayed / Cancelled:** Yes No N/A**Bridge No:** 34-0006**Component:** TA Yard OBG 12/13E**Summary of Items Observed:**

TRIAL ASSEMBLY

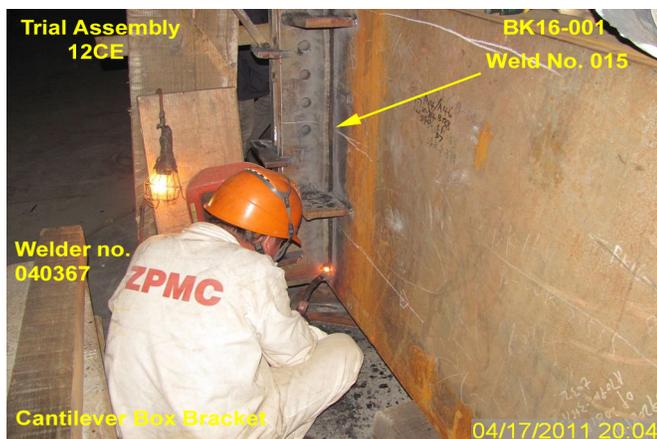
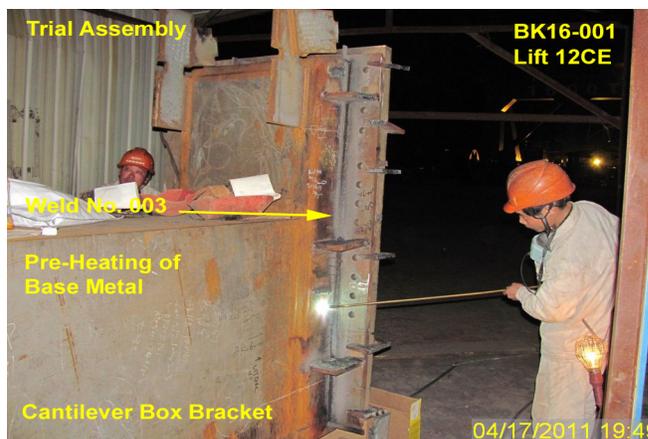
FCAW welding of complete joint penetration weld joint(s) located on lift 12CE, BK16-001 Cantilever Box Bracket weld number(s) 003. Welder is identified as welder no. 052763. The welding variables recorded by ZPMC QC identified as Wang Xiang Pin appeared to comply with applicable WPS(s) WPS-B-T-2233-ESAB.

FCAW welding of complete joint penetration weld joint(s) located on lift 12CE, BK16-001 Cantilever Box Bracket weld number(s) 015. Welder is identified as welder no. 040367. The welding variables recorded by ZPMC QC identified as Wang Xiang Pin appeared to comply with applicable WPS(s) WPS-B-T-2233-ESAB.

SMAW welding of complete joint penetration weld joint(s) located on lift 13CE, SEG3011F Floor Beam Edge Plate weld number(s) 173 and 174. Welder is identified as welder no. 051359. The welding variables recorded by ZPMC QC identified as Wang Xiang Pin appeared to comply with applicable WPS(s) WPS(s) WPS-345-SMAW-4G (4F)-FCM-Repair and B-WR20574.

SMAW welding of complete joint penetration weld joint(s) located on lift 13BE, SEG3009B I-Rib to Floor Beam weld number(s) 093 and 133. Welder is identified as welder no. 050969. The welding variables recorded by ZPMC QC identified as Wang Xiang Pin appeared to comply with applicable WPS(s) WPS(s) WPS-345-SMAW-4G (4F)-FCM-Repair and B-WR20574.

Unless otherwise noted, all work observed on this date appeared to generally comply with applicable contract documents.
