Contract #: 04-0120F4Cty: SF/ALA Rte: 80 PM: 13.2/13.9File #: 69.28**WELDING INSPECTION REPORT****Resident Engineer:** Siegenthaler, Peter**Address:** 333 Burma Road**City:** Oakland, CA 94607**Report No:** WIR-022699**Date Inspected:** 17-Apr-2011**Project Name:** SAS Superstructure**OSM Arrival Time:** 1500**Prime Contractor:** American Bridge/Fluor Enterprises, a JV**OSM Departure Time:** 300**Contractor:** Zhenhua Port Machinery Company, Ltd (ZPMC), Changxing Island **Location:** Shanghai, China**CWI Name:** See Below**CWI Present:** Yes No**Inspected CWI report:** Yes No N/A**Rod Oven in Use:** Yes No N/A**Electrode to specification:** Yes No N/A**Weld Procedures Followed:** Yes No N/A**Qualified Welders:** Yes No N/A**Verified Joint Fit-up:** Yes No N/A**Approved Drawings:** Yes No N/A**Approved WPS:** Yes No N/A**Delayed / Cancelled:** Yes No N/A**Bridge No:** 34-0006**Component:** OBG**Summary of Items Observed:**

WELDING INSPECTION REPORT

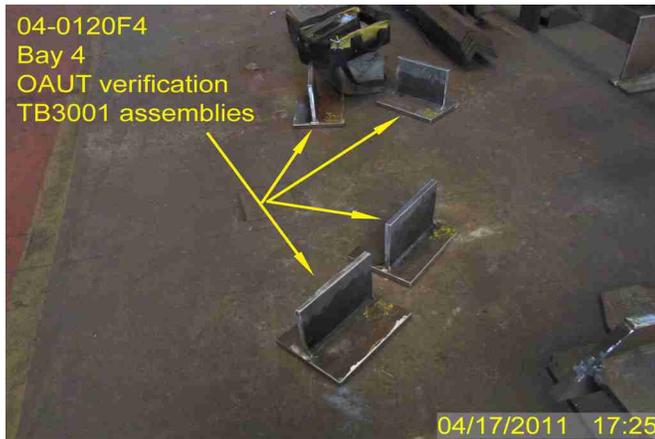
TB3001-009-001, TB3001-010-001, TB3001-011-001, TB3001-012-001

At the time of the verification it was noted that the above component appeared to be within compliance of the contract documents. See Caltrans Ultrasonic Test Report (TL6027), dated 04-17-2011 for additional information.

The following digital picture illustrates bracket assemblies QAUT verification for TB3001-.
