DEPARTMENT OF TRANSPORTATION

Quality Assurance and Source Inspection

Contract #: 04-0120F4Cty: SF/Ala Rte: 80 PM: 13.2/13.9File #: 69.28**WELDING INSPECTION REPORT****Resident Engineer:** Siegenthaler, Peter**Address:** 333 Burma Road**City:** Oakland, CA 94607**Report No:** WIR-022751**Date Inspected:** 25-Mar-2011**Project Name:** SAS Superstructure**OSM Arrival Time:** 1900**Prime Contractor:** American Bridge/Fluor Enterprises, a JV**OSM Departure Time:** 700**Contractor:** Zhenhua Port Machinery Company, Ltd (ZPMC), Changxing Island **Location:** Shanghai, China**CWI Name:** See below**CWI Present:** Yes No**Inspected CWI report:** Yes No N/A**Rod Oven in Use:** Yes No N/A**Electrode to specification:** Yes No N/A**Weld Procedures Followed:** Yes No N/A**Qualified Welders:** Yes No N/A**Verified Joint Fit-up:** Yes No N/A**Approved Drawings:** Yes No N/A**Approved WPS:** Yes No N/A**Delayed / Cancelled:** Yes No N/A**Bridge No:** 34-0006**Component:** OBG Components**Summary of Items Observed:**

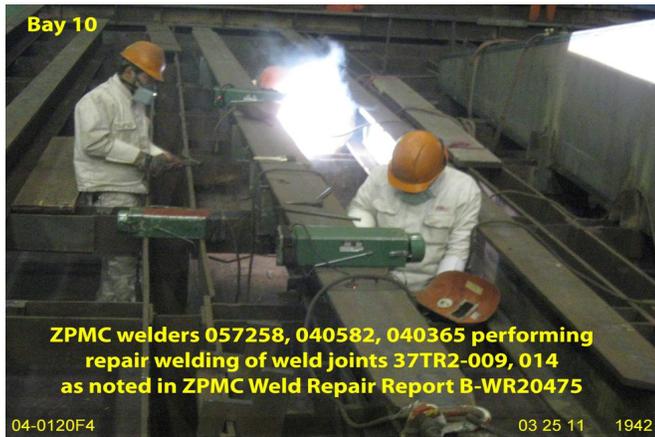
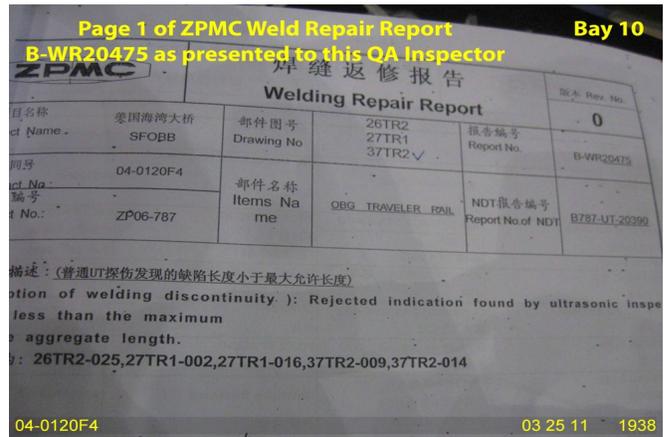
SMAW repair welding of weld joints 37TR2-009, 014 located on PCMK OBG traveler rail. Welders were identified as 057258, 040582, 040365. QC was identified as ZPMC CWI Xu Le Feng (QC1). Assisting QC1 at this location and appearing to be monitoring the welding operation and recording data was ZPMC QC Zhu Peng (QCA1), who was not a CWI. Weld variables recorded by QCA1 appeared to comply with WPS-345-SMAW-2G(2F)-repair as displayed on ZPMC Weld Repair Report B-WR20475 as presented to this QA Inspector and verbally identified by QCA1. See below for photo of page 1 of B-WR20475 and photo of welders 057258, 040582, 040365 performing repair welding operations.
