DEPARTMENT OF TRANSPORTATION

Contract #: 04-0120F4Cty: SF/ALA Rte: 80 PM: 13.2/13.9File #: 99.28**WELDING INSPECTION REPORT****Resident Engineer:** Siegenthaler, Peter**Address:** 333 Burma Road**City:** Oakland, CA 94607**Report No:** WIR-022797**Date Inspected:** 18-Apr-2011**Project Name:** SAS Superstructure**OSM Arrival Time:** 700**Prime Contractor:** American Bridge/Fluor Enterprises, a JV**OSM Departure Time:** 1900**Contractor:** Zhenhua Port Machinery Company, Ltd (ZPMC) Chanxing Island**Location:** Shanghai, China**CWI Name:** Mr. She Lei**CWI Present:** Yes No**Inspected CWI report:** Yes No N/A**Rod Oven in Use:** Yes No N/A**Electrode to specification:** Yes No N/A**Weld Procedures Followed:** Yes No N/A**Qualified Welders:** Yes No N/A**Verified Joint Fit-up:** Yes No N/A**Approved Drawings:** Yes No N/A**Approved WPS:** Yes No N/A**Delayed / Cancelled:** Yes No N/A**Bridge No:** 34-0006**Component:** OBG Segment**Summary of Items Observed:**

WELDING INSPECTION REPORT

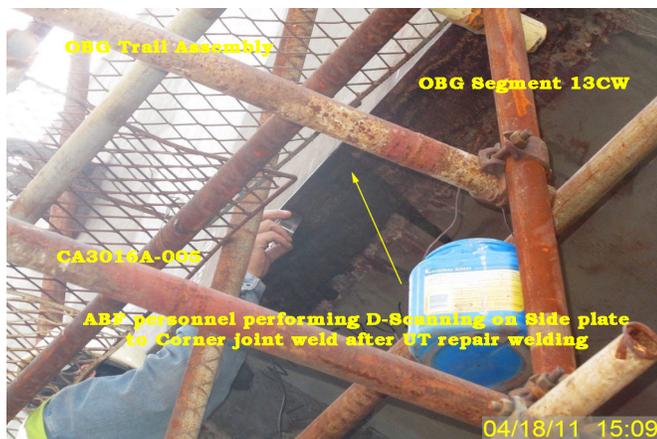
This QA inspector observed ABF personnel performed Ultrasonic Testing (UT) 'D' Scanning repair area on Side Plate to Corner Assembly of OBG Segment 13CW. The weld number is identified as CA3016A-005. See the attached picture.
