DEPARTMENT OF TRANSPORTATION

Contract #: 04-0120F4Cty: SF/ALA Rte: 80 PM: 13.2/13.9File #: 69.28**WELDING INSPECTION REPORT****Resident Engineer:** Siegenthaler, Peter**Address:** 333 Burma Road**City:** Oakland, CA 94607**Report No:** WIR-022803**Date Inspected:** 18-Apr-2011**Project Name:** SAS Superstructure**OSM Arrival Time:** 700**Prime Contractor:** American Bridge/Fluor Enterprises, a JV**OSM Departure Time:** 1900**Contractor:** Zhenhua Port Machinery Company, Ltd (ZPMC), Changxing Island **Location:** Shanghai, China**CWI Name:** Liu Hua Jie**CWI Present:** Yes No**Inspected CWI report:** Yes No N/A**Rod Oven in Use:** Yes No N/A**Electrode to specification:** Yes No N/A**Weld Procedures Followed:** Yes No N/A**Qualified Welders:** Yes No N/A**Verified Joint Fit-up:** Yes No N/A**Approved Drawings:** Yes No N/A**Approved WPS:** Yes No N/A**Delayed / Cancelled:** Yes No N/A**Bridge No:** 34-0006**Component:** OBG**Summary of Items Observed:**

OBG Trial Assembly

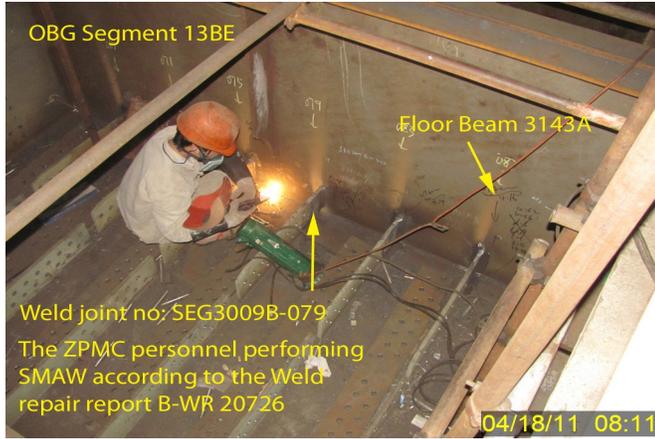
SMAW welding of weld joint No: SEG3009B-079 located on OBG Segment 13BE Bottom panel stiffener to Floor beam. Welder is identified as #050969. ZPMC QC is identified as Mr. Zhan Hai Feng. Welding was performed with the weld repair report BWR-20726. The welding variables recorded by QC appeared to comply with the WPS-345-SMAW-3G(3F)-FCM-Repair-1. Please see the attached picture.

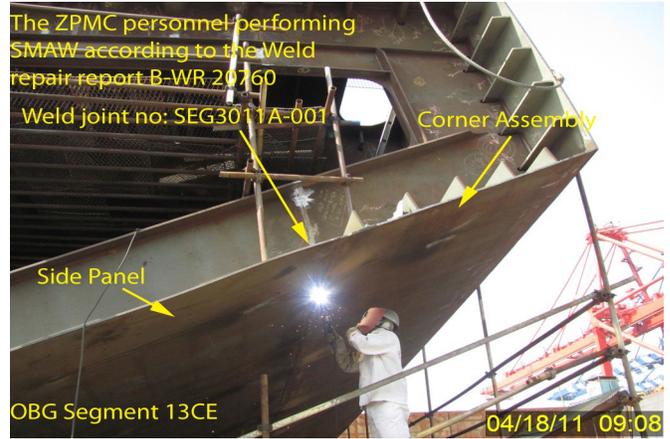
SMAW welding of weld joint No: SEG3011A-001 located on OBG Segment 13CE Side panel to Corner Assembly. Welder is identified as #066258. ZPMC QC is identified as Mr. Zhan Hai Feng. Welding was performed with the weld repair report BWR-20760. The welding variables recorded by QC appeared to comply with the WPS-345-SMAW-4G(4F)-FCM-Repair-1. Please see the attached picture.
