DEPARTMENT OF TRANSPORTATION

Contract #: 04-0120F4Cty: SF/ALA Rte: 80 PM: 13.2/13.9File #: 69.28**WELDING INSPECTION REPORT****Resident Engineer:** Siegenthaler, Peter**Address:** 333 Burma Road**City:** Oakland, CA 94607**Report No:** WIR-022808**Date Inspected:** 20-Mar-2011**Project Name:** SAS Superstructure**OSM Arrival Time:** 700**Prime Contractor:** American Bridge/Fluor Enterprises, a JV**OSM Departure Time:** 1900**Contractor:** Zhenhua Port Machinery Company, Ltd (ZPMC), Changxing Island **Location:** Shanghai, China**CWI Name:** Geng Wei**CWI Present:** Yes No**Inspected CWI report:** Yes No N/A**Rod Oven in Use:** Yes No N/A**Electrode to specification:** Yes No N/A**Weld Procedures Followed:** Yes No N/A**Qualified Welders:** Yes No N/A**Verified Joint Fit-up:** Yes No N/A**Approved Drawings:** Yes No N/A**Approved WPS:** Yes No N/A**Delayed / Cancelled:** Yes No N/A**Bridge No:** 34-0006**Component:** OBG**Summary of Items Observed:**

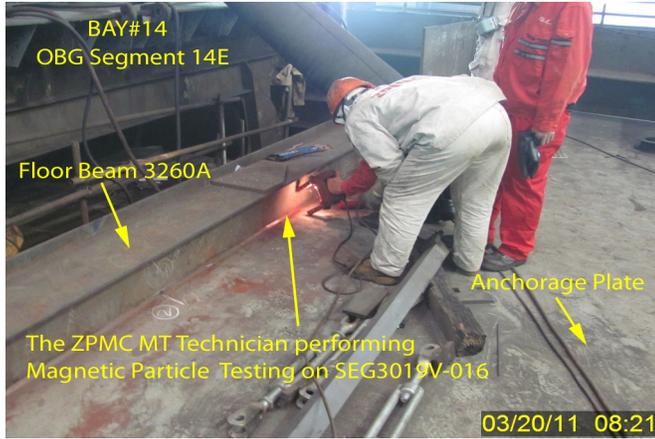
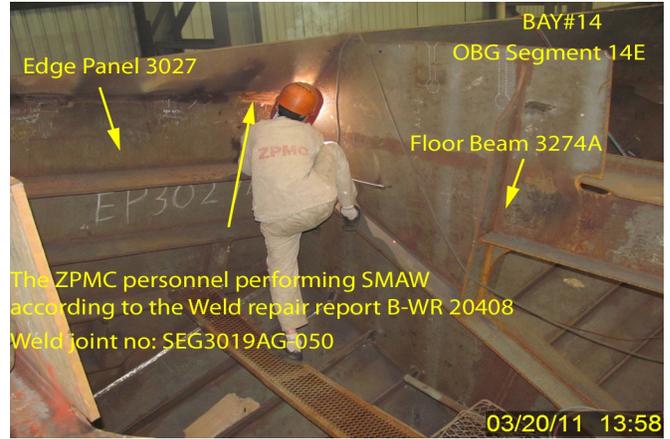
SMAW welding of weld joint no: SEG3019AG-050 located on OBG Segment 14E Edge Panel to Side Panel. Welder is identified as #043661. ZPMC QC is identified as Mr. Zhu Yuan Yuan. Welding was performed according to the weld repair report B-WR20408. The welding variables recorded by QC appeared to comply with the WPS-345-SMAW-4G(4F)-FCM-Repair-1. Please see the attached picture.
