Contract #: 04-0120F4Cty: SF/ALA Rte: 80 PM: 13.2/13.9File #: 69.28**WELDING INSPECTION REPORT****Resident Engineer:** Siegenthaler, Peter**Address:** 333 Burma Road**City:** Oakland, CA 94607**Report No:** WIR-022825**Date Inspected:** 02-Apr-2011**Project Name:** SAS Superstructure**OSM Arrival Time:** 700**Prime Contractor:** American Bridge/Fluor Enterprises, a JV**OSM Departure Time:** 1900**Contractor:** Zhenhua Port Machinery Company, Ltd (ZPMC), Changxing Island **Location:** Shanghai, China**CWI Name:** Li yan hua**CWI Present:** Yes No**Inspected CWI report:** Yes No N/A**Rod Oven in Use:** Yes No N/A**Electrode to specification:** Yes No N/A**Weld Procedures Followed:** Yes No N/A**Qualified Welders:** Yes No N/A**Verified Joint Fit-up:** Yes No N/A**Approved Drawings:** Yes No N/A**Approved WPS:** Yes No N/A**Delayed / Cancelled:** Yes No N/A**Bridge No:** 34-0006**Component:** OBG Components**Summary of Items Observed:**

WELDING INSPECTION REPORT

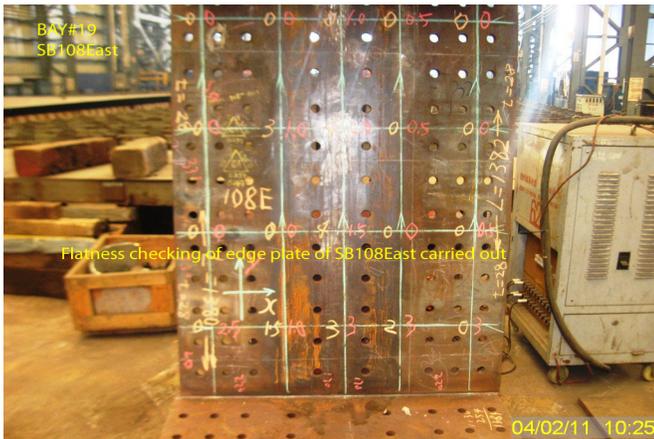
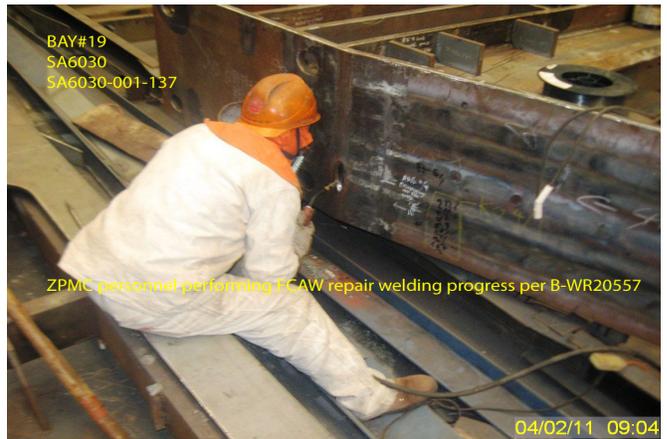
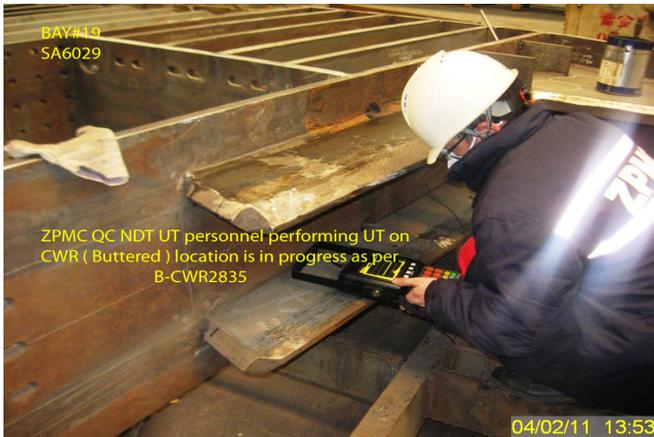
This QA inspector performed joint dimensional inspection of flatness check with ABF QA Mr. Peng wen jun on Suspende bracket SB106 East, West and SB108 East after critical weld repair (CWR) and Heat straightening carried out. See the attached photos.

Flatness check of edge plate	Min	Max
108East		
X-axis	0	4
Y-axis	0	3
106East		
X-axis	0	3
Y-axis	0	4
106West		
X-axis	0	6.5
Y-axis	0	8.5
