DEPARTMENT OF TRANSPORTATION

Quality Assurance and Source Inspection

Contract #: 04-0120F4Cty: SF/ALA Rte: 80 PM: 13.2/13.9File #: 69.28**WELDING INSPECTION REPORT****Resident Engineer:** Siegenthaler, Peter**Address:** 333 Burma Road**City:** Oakland, CA 94607**Report No:** WIR-022860**Date Inspected:** 21-Apr-2011**Project Name:** SAS Superstructure**OSM Arrival Time:** 700**Prime Contractor:** American Bridge/Fluor Enterprises, a JV**OSM Departure Time:** 1900**Contractor:** Zhenhua Port Machinery Company, Ltd (ZPMC), Changxing Island **Location:** Shanghai, China**CWI Name:** Liu Hua Jie.**CWI Present:** Yes No**Inspected CWI report:** Yes No N/A**Rod Oven in Use:** Yes No N/A**Electrode to specification:** Yes No N/A**Weld Procedures Followed:** Yes No N/A**Qualified Welders:** Yes No N/A**Verified Joint Fit-up:** Yes No N/A**Approved Drawings:** Yes No N/A**Approved WPS:** Yes No N/A**Delayed / Cancelled:** Yes No N/A**Bridge No:** 34-0006**Component:** OBG components.**Summary of Items Observed:**

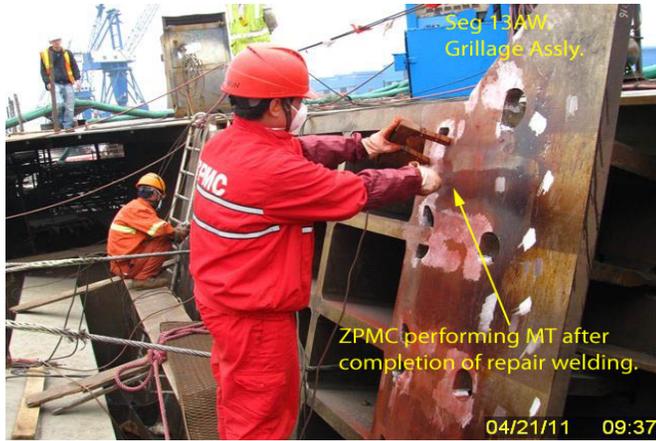
Grillage assembly on Seg 13AW:

ZPMC personnel performing Magnetic Particle Testing (MT) after completion of repair welding. Linear indications were again observed after MT was done. These were identified for repair welding. This QA Inspector informed ZPMC QC, identified as Sun Tian Liang to submit revised Critical Welding Repair Report (CWR) before performing repair welding. See attached photo for further details.
