**DEPARTMENT OF TRANSPORTATION**

Contract #: 04-0120F4Cty: SF/ALA Rte: 80 PM: 13.2/13.9File #: 69.28**WELDING INSPECTION REPORT****Resident Engineer:** Siegenthaler, Peter**Address:** 333 Burma Road**City:** Oakland, CA 94607**Report No:** WIR-022966**Date Inspected:** 24-Apr-2011**Project Name:** SAS Superstructure**OSM Arrival Time:** 700**Prime Contractor:** American Bridge/Fluor Enterprises, a JV**OSM Departure Time:** 1900**Contractor:** Zhenhua Port Machinery Company, Ltd (ZPMC), Changxing Island **Location:** Shanghai, China**CWI Name:** An Qing Xiang**CWI Present:** Yes No**Inspected CWI report:** Yes No N/A**Rod Oven in Use:** Yes No N/A**Electrode to specification:** Yes No N/A**Weld Procedures Followed:** Yes No N/A**Qualified Welders:** Yes No N/A**Verified Joint Fit-up:** Yes No N/A**Approved Drawings:** Yes No N/A**Approved WPS:** Yes No N/A**Delayed / Cancelled:** Yes No N/A**Bridge No:** 34-0006**Component:** OBG**Summary of Items Observed:**

## WELDING INSPECTION REPORT

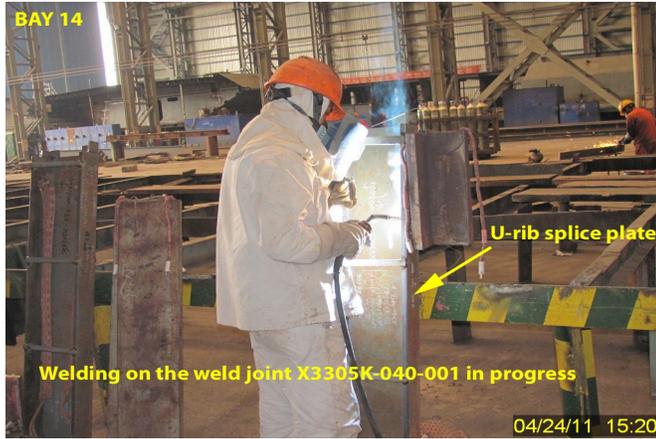
The FCAW process on weld joint no: X3305K-040-001/002. The welder is identified as 045175 and was observed welding in 3G position. ZPMC QC was identified as Mr. An Qing Xiang. The welding variables recorded by this QC appeared to comply with WPS: B-T-2233-ESAB. Attached photograph provide additional details.
