Contract #: 04-0120F4Cty: SF/ALA Rte: 80 PM: 13.2/13.9File #: 69.28**WELDING INSPECTION REPORT****Resident Engineer:** Siegenthaler, Peter**Address:** 333 Burma Road**City:** Oakland, CA 94607**Report No:** WIR-022971**Date Inspected:** 24-Apr-2011**Project Name:** SAS Superstructure**OSM Arrival Time:** 700**Prime Contractor:** American Bridge/Fluor Enterprises, a JV**OSM Departure Time:** 1900**Contractor:** Zhenhua Port Machinery Company, Ltd (ZPMC), Changxing Island **Location:** Shanghai, China

Bridge No: 34-0006**Component:** Orthotropic Box Girder (OBG)**Summary of Items Observed:**

OBG Trial Assembly open yard.

Segment: 13AW

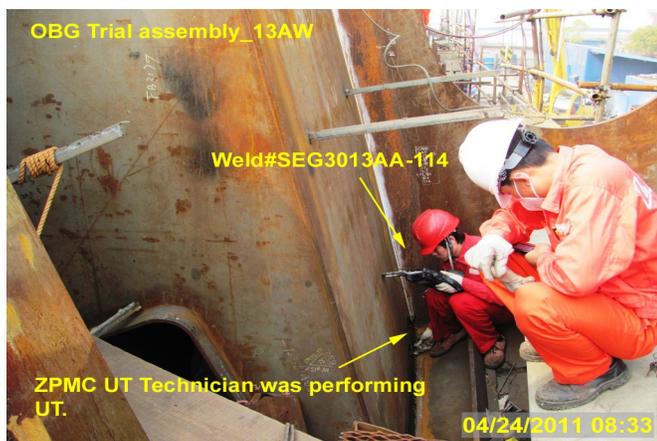
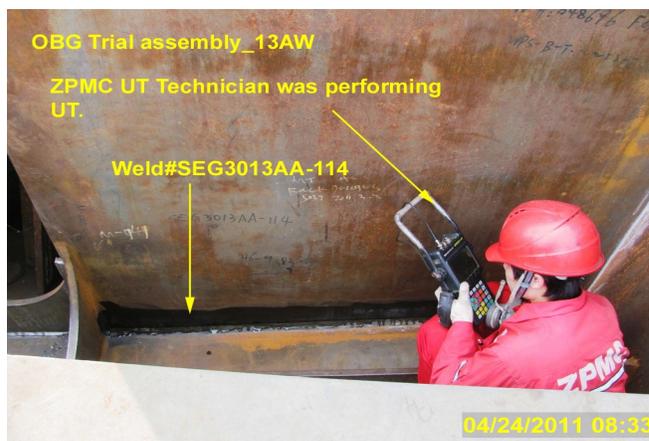
ZPMC UT Technician was performing Ultrasonic Testing for the weld joint identified as SEG3013AA-114. See attached photos for further details.
