**DEPARTMENT OF TRANSPORTATION**

Contract #: 04-0120F4Cty: SF/ALA Rte: 80 PM: 13.2/13.9File #: 69.28**WELDING INSPECTION REPORT****Resident Engineer:** Siegenthaler, Peter**Address:** 333 Burma Road**City:** Oakland, CA 94607**Report No:** WIR-023000**Date Inspected:** 24-Apr-2011**Project Name:** SAS Superstructure**OSM Arrival Time:** 700**Prime Contractor:** American Bridge/Fluor Enterprises, a JV**OSM Departure Time:** 1900**Contractor:** Zhenhua Port Machinery Company, Ltd (ZPMC), Changxing Island **Location:** Shanghai, China**CWI Name:** Zhu Zhong Hai**CWI Present:** Yes No**Inspected CWI report:** Yes No N/A**Rod Oven in Use:** Yes No N/A**Electrode to specification:** Yes No N/A**Weld Procedures Followed:** Yes No N/A**Qualified Welders:** Yes No N/A**Verified Joint Fit-up:** Yes No N/A**Approved Drawings:** Yes No N/A**Approved WPS:** Yes No N/A**Delayed / Cancelled:** Yes No N/A**Bridge No:** 34-0006**Component:** OBG Segments**Summary of Items Observed:**

## WELDING INSPECTION REPORT

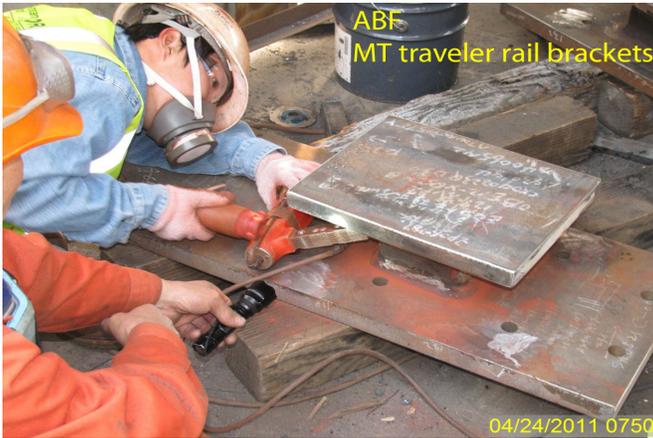
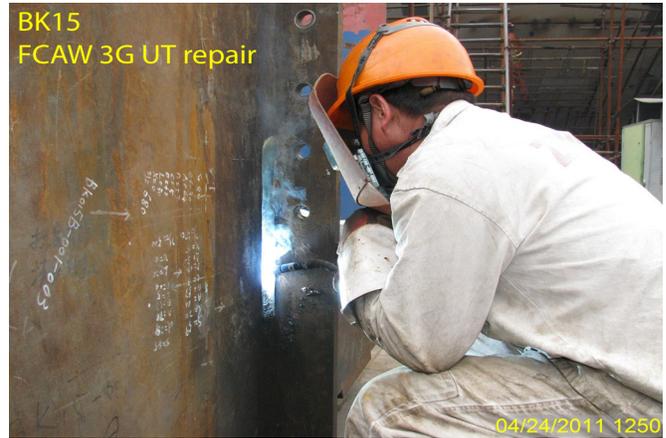
This QA Inspector observed ABF personnel performing Ultrasonic Testing on the Edge Plate to Deck Plate hold back weld, bike path side at west end of segment.

Unless otherwise noted, all work observed on this date appeared to generally comply with applicable contract documents.
