DEPARTMENT OF TRANSPORTATION

Quality Assurance and Source Inspection

Contract #: 04-0120F4Cty: SF/ALA Rte: 80 PM: 13.2/13.9File #: 69.28**WELDING INSPECTION REPORT****Resident Engineer:** Siegenthaler, Peter**Address:** 333 Burma Road**City:** Oakland, CA 94607**Report No:** WIR-023023**Date Inspected:** 27-Mar-2011**Project Name:** SAS Superstructure**OSM Arrival Time:** 700**Prime Contractor:** American Bridge/Fluor Enterprises, a JV**OSM Departure Time:** 1900**Contractor:** Zhenhua Port Machinery Company, Ltd (ZPMC), Changxing Island **Location:** Shanghai, China**CWI Name:** Xu Le Feng / Qiu Wen**CWI Present:** Yes No**Inspected CWI report:** Yes No N/A**Rod Oven in Use:** Yes No N/A**Electrode to specification:** Yes No N/A**Weld Procedures Followed:** Yes No N/A**Qualified Welders:** Yes No N/A**Verified Joint Fit-up:** Yes No N/A**Approved Drawings:** Yes No N/A**Approved WPS:** Yes No N/A**Delayed / Cancelled:** Yes No N/A**Bridge No:** 34-0006**Component:** OBG Bike Path**Summary of Items Observed:**

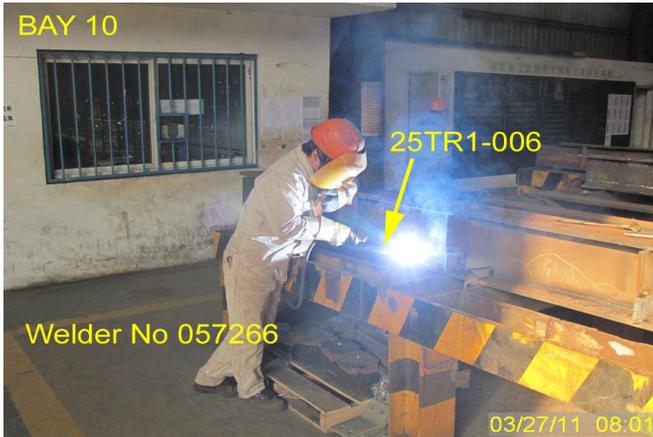
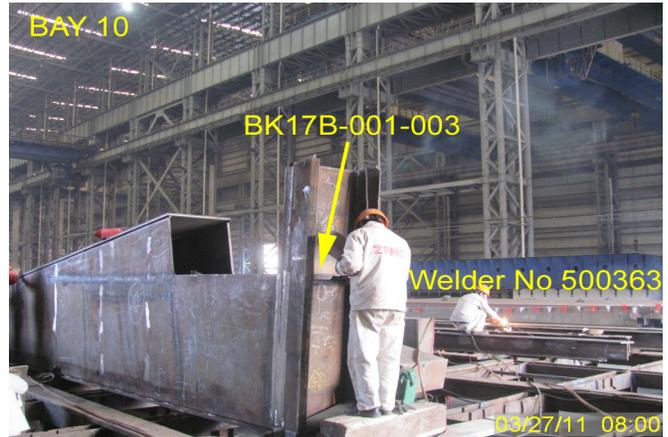
This QA Inspector observed the following work in progress: FCAW welding of weld joint 006 located on 25TR1-001. Welder is identified as 057266. ZPMC Quality Control (QC) is identified as Qui Wen. The welding variables recorded by QC appeared to comply with the Applicable WPS.

This QA Inspector observed the following work in progress: SMAW welding of weld joint 043 located on BK014A1-001. Welder is identified as 053869. ZPMC Quality Control (QC) is identified as Qui Wen. The welding variables recorded by QC appeared to comply with the Applicable WPS.
