**DEPARTMENT OF TRANSPORTATION**

Contract #: 04-0120F4Cty: SF/ALA Rte: 80 PM: 13.2/13.9File #: 69.28**WELDING INSPECTION REPORT****Resident Engineer:** Siegenthaler, Peter**Address:** 333 Burma Road**City:** Oakland, CA 94607**Report No:** WIR-023044**Date Inspected:** 25-Mar-2011**Project Name:** SAS Superstructure**OSM Arrival Time:** 700**Prime Contractor:** American Bridge/Fluor Enterprises, a JV**OSM Departure Time:** 1900**Contractor:** Zhenhua Port Machinery Company, Ltd (ZPMC), Changxing Island **Location:** Shanghai, China**CWI Name:** Xu Le Feng**CWI Present:** Yes No**Inspected CWI report:** Yes No N/A**Rod Oven in Use:** Yes No N/A**Electrode to specification:** Yes No N/A**Weld Procedures Followed:** Yes No N/A**Qualified Welders:** Yes No N/A**Verified Joint Fit-up:** Yes No N/A**Approved Drawings:** Yes No N/A**Approved WPS:** Yes No N/A**Delayed / Cancelled:** Yes No N/A**Bridge No:** 34-0006**Component:** OBG Components**Summary of Items Observed:**

## WELDING INSPECTION REPORT

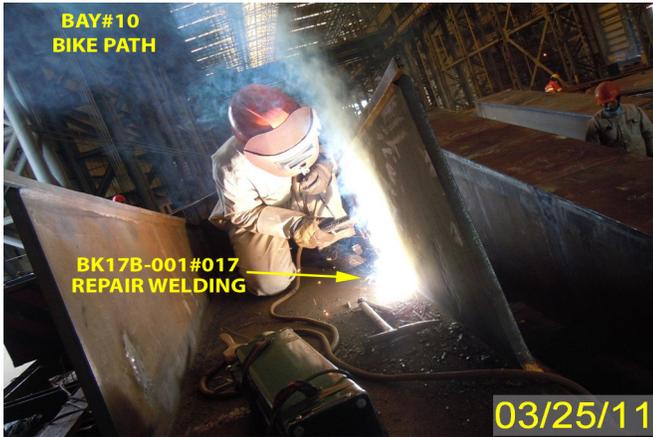
Repair welding of weld joint #017 located on Bike Path BK17B-001 as per the weld repair report#B-WR20489.

Welder is identified as 057258. ZPMC Quality Control (QC) Inspector is identified as Jiang Xiao Bo. The welding variables recorded by QC appeared to comply with the WPS-345-SMAW-1G (1F)-REPAIR. (See attached photo)

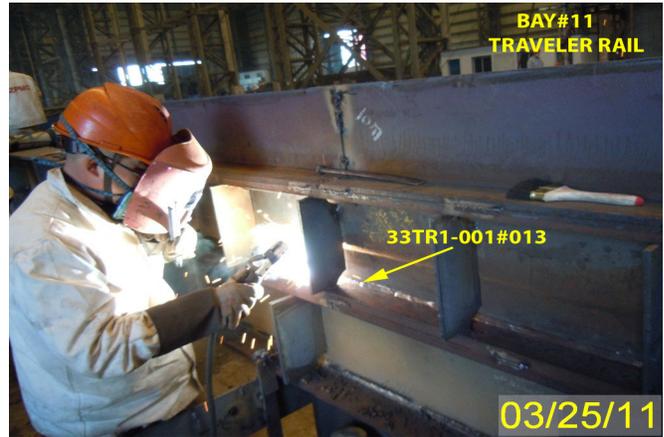
Weld joint #013 located on Traveler Rail 33TR1-001. Welder is identified as 044541. ZPMC Quality Control (QC) Inspector is identified as Wang Chuang Xin. The welding variables recorded by QC appeared to comply with the WPS-B-P-2212-Tc-U5b. (See attached photo)
