DEPARTMENT OF TRANSPORTATION

Quality Assurance and Source Inspection

Contract #: 04-0120F4Cty: SF/ALA Rte: 80 PM: 13.2/13.9File #: 69.28**WELDING INSPECTION REPORT****Resident Engineer:** Siegenthaler, Peter**Address:** 333 Burma Road**City:** Oakland, CA 94607**Report No:** WIR-023046**Date Inspected:** 27-Mar-2011**Project Name:** SAS Superstructure**OSM Arrival Time:** 700**Prime Contractor:** American Bridge/Fluor Enterprises, a JV**OSM Departure Time:** 1900**Contractor:** Zhenhua Port Machinery Company, Ltd (ZPMC), Changxing Island **Location:** Shanghai, China**CWI Name:** Xu Le Feng**CWI Present:** Yes No**Inspected CWI report:** Yes No N/A**Rod Oven in Use:** Yes No N/A**Electrode to specification:** Yes No N/A**Weld Procedures Followed:** Yes No N/A**Qualified Welders:** Yes No N/A**Verified Joint Fit-up:** Yes No N/A**Approved Drawings:** Yes No N/A**Approved WPS:** Yes No N/A**Delayed / Cancelled:** Yes No N/A**Bridge No:** 34-0006**Component:** OBG & TOWER Components**Summary of Items Observed:**

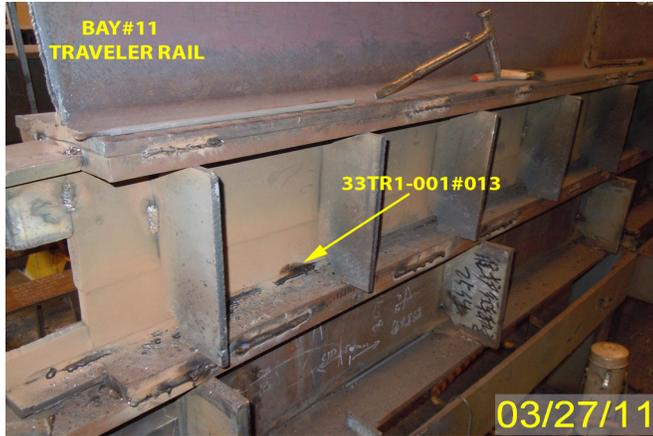
Weld joint #013 located on Traveler Rail 33TR1-001. Welder is identified as 046769. ZPMC Quality Control (QC) Inspector is identified as Wang Chuang Xin. The welding variables recorded by QC appeared to comply with the WPS-B-P-2212-Tc-U5b. (See attached photo)

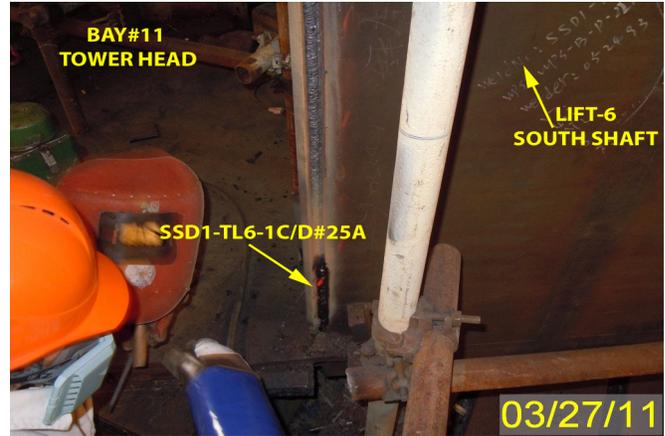
Weld joint #25A located on South shaft lift-6, tower head SSD1-TL6-1C/D. Welder is identified as 500363. ZPMC Quality Control (QC) Inspector is identified as Yu Zhi Lai. The welding variables recorded by QC appeared to comply with the WPS-B-P-2213-Tc-U4b. (See attached photo)
