**DEPARTMENT OF TRANSPORTATION**

Quality Assurance and Source Inspection

Contract #: 04-0120F4Cty: SF/ALA Rte: 80 PM: 13.2/13.9File #: 69.28**WELDING INSPECTION REPORT****Resident Engineer:** Siegenthaler, Peter**Address:** 333 Burma Road**City:** Oakland, CA 94607**Report No:** WIR-023048**Date Inspected:** 29-Mar-2011**Project Name:** SAS Superstructure**OSM Arrival Time:** 700**Prime Contractor:** American Bridge/Fluor Enterprises, a JV**OSM Departure Time:** 1900**Contractor:** Zhenhua Port Machinery Company, Ltd (ZPMC), Changxing Island **Location:** Shanghai, China**CWI Name:** Xu Le Feng**CWI Present:** Yes No**Inspected CWI report:** Yes No N/A**Rod Oven in Use:** Yes No N/A**Electrode to specification:** Yes No N/A**Weld Procedures Followed:** Yes No N/A**Qualified Welders:** Yes No N/A**Verified Joint Fit-up:** Yes No N/A**Approved Drawings:** Yes No N/A**Approved WPS:** Yes No N/A**Delayed / Cancelled:** Yes No N/A**Bridge No:** 34-0006**Component:** OBG & TOWER Components**Summary of Items Observed:**

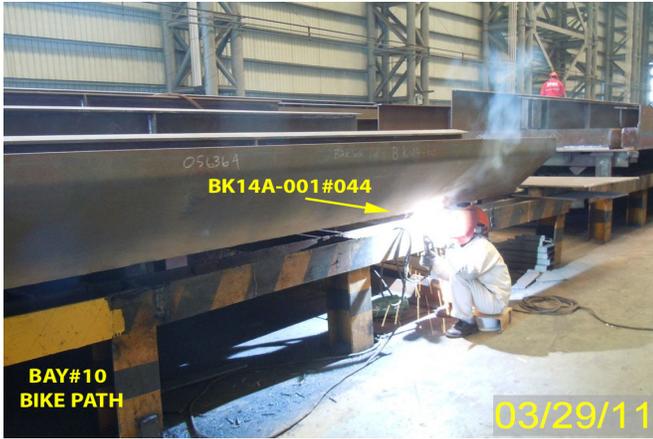
Weld joint #044 located on Bike Path BK14A-001. Welder is identified as 056364. ZPMC Quality Control (QC) Inspector is identified as Shi Yu. The welding variables recorded by QC appeared to comply with the WPS-B-P-2214-B-U2 (See attached photo)

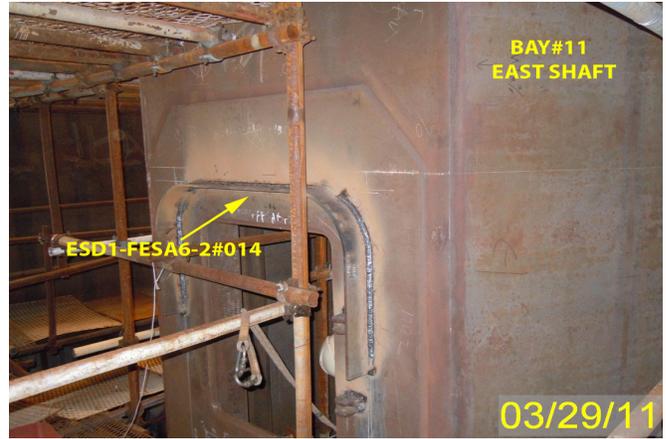
Weld joint #14 located on East shaft lift-6, tower head ESD1-FESA6-2. Welder is identified as 046769. ZPMC Quality Control (QC) Inspector is identified as Mao Bin Bin. The welding variables recorded by QC appeared to comply with the WPS-B-P-2114. (See attached photo)
