**DEPARTMENT OF TRANSPORTATION**

Contract #: 04-0120F4Cty: SF/ALA Rte: 80 PM: 13.2/13.9File #: 69.28**WELDING INSPECTION REPORT****Resident Engineer:** Siegenthaler, Peter**Address:** 333 Burma Road**City:** Oakland, CA 94607**Report No:** WIR-023058**Date Inspected:** 09-Apr-2011**Project Name:** SAS Superstructure**OSM Arrival Time:** 700**Prime Contractor:** American Bridge/Fluor Enterprises, a JV**OSM Departure Time:** 1900**Contractor:** Zhenhua Port Machinery Company, Ltd (ZPMC), Changxing Island **Location:** Shanghai, China**CWI Name:** Xu Le Feng**CWI Present:** Yes No**Inspected CWI report:** Yes No N/A**Rod Oven in Use:** Yes No N/A**Electrode to specification:** Yes No N/A**Weld Procedures Followed:** Yes No N/A**Qualified Welders:** Yes No N/A**Verified Joint Fit-up:** Yes No N/A**Approved Drawings:** Yes No N/A**Approved WPS:** Yes No N/A**Delayed / Cancelled:** Yes No N/A**Bridge No:** 34-0006**Component:** OBG & TOWER Components**Summary of Items Observed:**

## WELDING INSPECTION REPORT

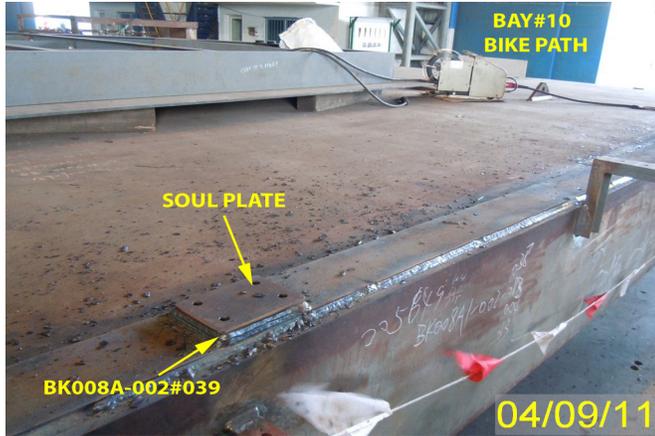
Weld joint #039 located on Bike path BK008A-002. Welder is identified as 205649. ZPMC Quality Control (QC) Inspector is identified as Shang Hai Lang. The welding variables recorded by QC appeared to comply with the WPS-B-T-2232-ESAB. (See attached photo)

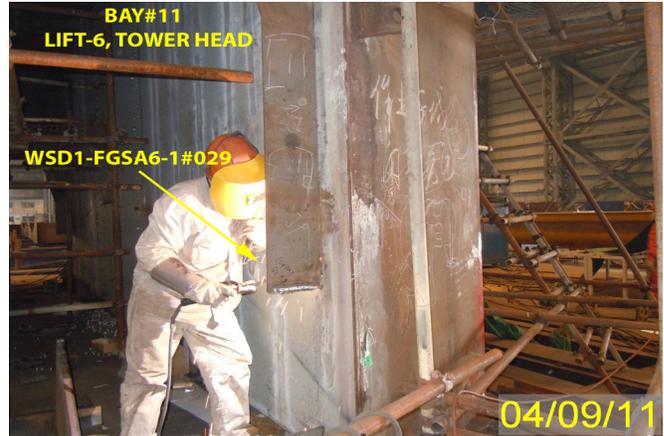
Weld joint #029 located on Lift-6 Tower head component WSD1-FGSA6-1. Welder is identified as 041271. ZPMC Quality Control (QC) Inspector is identified as Yu Zhi Lai. The welding variables recorded by QC appeared to comply with the WPS-B-P-2313-Tc-P4. (See attached photo)
