DEPARTMENT OF TRANSPORTATION

Quality Assurance and Source Inspection

Contract #: 04-0120F4Cty: SF/ALA Rte: 80 PM: 13.2/13.9File #: 69.28**WELDING INSPECTION REPORT****Resident Engineer:** Siegenthaler, Peter**Address:** 333 Burma Road**City:** Oakland, CA 94607**Report No:** WIR-023075**Date Inspected:** 24-Mar-2011**Project Name:** SAS Superstructure**OSM Arrival Time:** 1500**Prime Contractor:** American Bridge/Fluor Enterprises, a JV**OSM Departure Time:** 300**Contractor:** Zhenhua Port Machinery Company, Ltd (ZPMC), Changxing Island **Location:** Shanghai, China**CWI Name:** Mr. Li Yan Hua**CWI Present:** Yes No**Inspected CWI report:** Yes No N/A**Rod Oven in Use:** Yes No N/A**Electrode to specification:** Yes No N/A**Weld Procedures Followed:** Yes No N/A**Qualified Welders:** Yes No N/A**Verified Joint Fit-up:** Yes No N/A**Approved Drawings:** Yes No N/A**Approved WPS:** Yes No N/A**Delayed / Cancelled:** Yes No N/A**Bridge No:** 34-0006**Component:** OBG**Summary of Items Observed:**

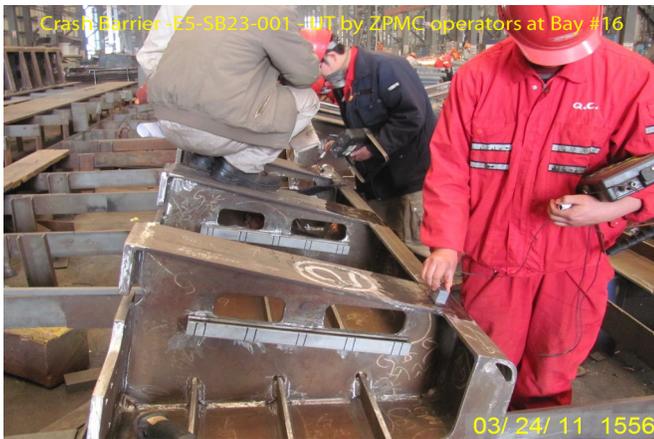
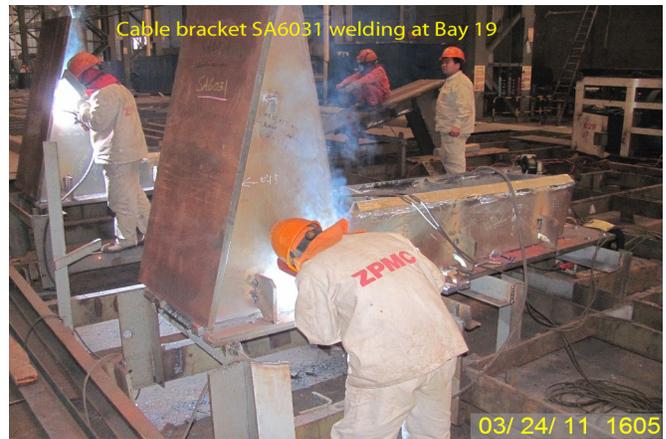
For further information see below pictures:-

Unless otherwise noted, all work observed on this date appeared to be in general compliance with the applicable contract documents.
