DEPARTMENT OF TRANSPORTATION

Quality Assurance and Source Inspection

Contract #: 04-0120F4Cty: SF/ALA Rte: 80 PM: 13.2/13.9File #: 82.28**WELDING INSPECTION REPORT****Resident Engineer:** Siegenthaler, Peter**Address:** 333 Burma Road**City:** Oakland, CA 94607**Report No:** WIR-023097**Date Inspected:** 21-Apr-2011**Project Name:** SAS Superstructure**OSM Arrival Time:** 630**Prime Contractor:** American Bridge/Fluor Enterprises, a JV**OSM Departure Time:** 1500**Contractor:** Westmont Industries**Location:** Santa Fe Springs, CA**CWI Name:** Ruben Dominguez**CWI Present:** Yes No**Inspected CWI report:** Yes No N/A**Rod Oven in Use:** Yes No N/A**Electrode to specification:** Yes No N/A**Weld Procedures Followed:** Yes No N/A**Qualified Welders:** Yes No N/A**Verified Joint Fit-up:** Yes No N/A**Approved Drawings:** Yes No N/A**Approved WPS:** Yes No N/A**Delayed / Cancelled:** Yes No N/A**Bridge No:** 34-0006 L & R**Component:** Maintenance Travelers**Summary of Items Observed:**

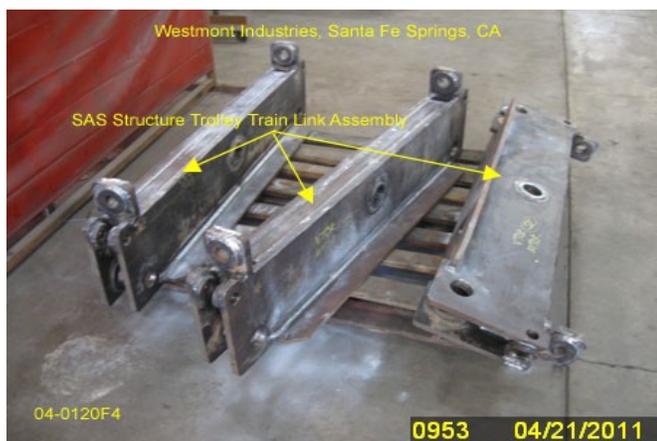
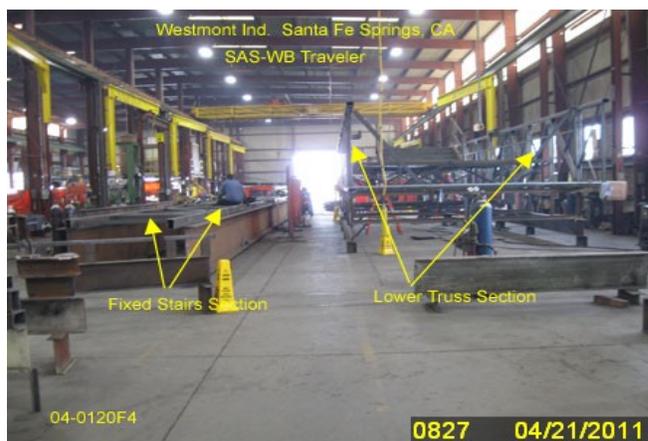
This QA Inspector observed that the activities mentioned above, appeared to be in compliance with the contract requirements and this QA Inspector observed no non-conforming issues, on this date.
