**DEPARTMENT OF TRANSPORTATION**

Contract #: 04-0120F4Cty: SF/ALA Rte: 80 PM: 13.2/13.9File #: 69.28**WELDING INSPECTION REPORT****Resident Engineer:** Siegenthaler, Peter**Address:** 333 Burma Road**City:** Oakland, CA 94607**Report No:** WIR-023134**Date Inspected:** 01-Apr-2011**Project Name:** SAS Superstructure**OSM Arrival Time:** 1900**Prime Contractor:** American Bridge/Fluor Enterprises, a JV**OSM Departure Time:** 700**Contractor:** Zhenhua Port Machinery Company, Ltd (ZPMC), Changxing Island **Location:** Shanghai, China**CWI Name:** See below**CWI Present:** Yes No**Inspected CWI report:** Yes No N/A**Rod Oven in Use:** Yes No N/A**Electrode to specification:** Yes No N/A**Weld Procedures Followed:** Yes No N/A**Qualified Welders:** Yes No N/A**Verified Joint Fit-up:** Yes No N/A**Approved Drawings:** Yes No N/A**Approved WPS:** Yes No N/A**Delayed / Cancelled:** Yes No N/A**Bridge No:** 34-0006**Component:** OBG**Summary of Items Observed:**

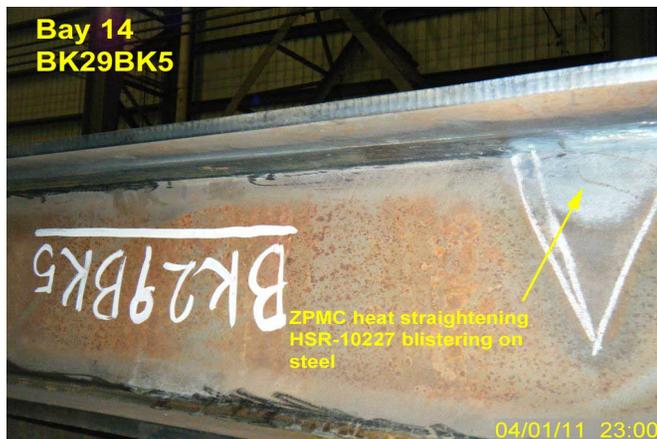
Heat straightening of PCMK, BK29BK5 under approved Heat Straightening procedure, HSR1 (B)-10227. The in process temperature was observed as 630°C. The ZPMC QC was identified as Guo Xing Hai. The approved HSR procedure stated that a maximum temperature of 650°C with 1-3 numbers of applications was allowed. The distortion that was previously measured and recorded on the HSR was Maximum 6mm.

(see photo below)

During random inspection of bike path beams this QA Inspector observed BK29BK5 had what appears to be signs of overheating “blistering” on the web of the beam. This QA Inspector, ZPMC Quality Control Guo Xing Hai, American Bridge / Flour Quality Assurance Chen Kun, and the ZPMC employee performing the heat straightening reviewed document HSR1 (B) 10227 with special attention given to maximum temperature 650°C. After this conversation no other action is required at this time.
