Contract #: 04-0120F4Cty: SF/ALA Rte: 80 PM: 13.2/13.9File #: 69.28**WELDING INSPECTION REPORT****Resident Engineer:** Siegenthaler, Peter**Address:** 333 Burma Road**City:** Oakland, CA 94607**Report No:** WIR-023151**Date Inspected:** 28-Apr-2011**Project Name:** SAS Superstructure**OSM Arrival Time:** 1900**Prime Contractor:** American Bridge/Fluor Enterprises, a JV**OSM Departure Time:** 700**Contractor:** Zhenhua Port Machinery Company, Ltd (ZPMC), Changxing Island **Location:** Shanghai, China**CWI Name:** See Below**CWI Present:** Yes No**Inspected CWI report:** Yes No N/A**Rod Oven in Use:** Yes No N/A**Electrode to specification:** Yes No N/A**Weld Procedures Followed:** Yes No N/A**Qualified Welders:** Yes No N/A**Verified Joint Fit-up:** Yes No N/A**Approved Drawings:** Yes No N/A**Approved WPS:** Yes No N/A**Delayed / Cancelled:** Yes No N/A**Bridge No:** 34-0006**Component:** OBG**Summary of Items Observed:**

WELDING INSPECTION REPORT

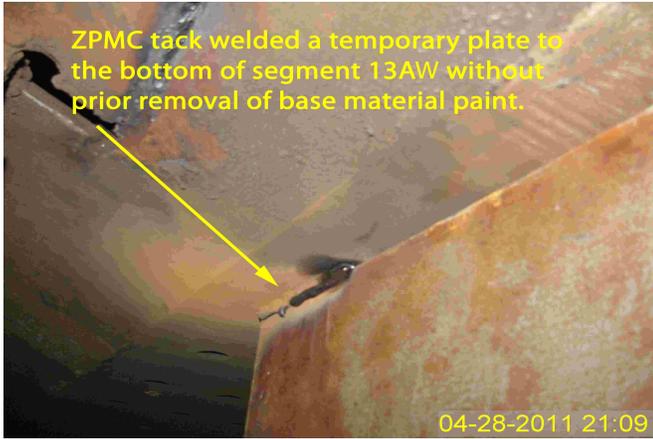
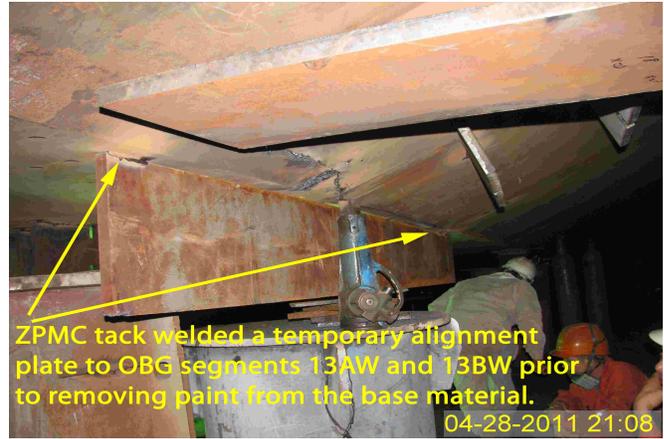
This QA Inspector observed ZPMC welder Mr. Zhao Aifei, stencil 067942 SMAW had performed tack welding of a temporary alignment plate to the cross beam side of the joint between segments 13AE/13BE side plate/ bottom plate. ZPMC did not appear to have removed any of the paint where the tack welds had been made. This QA Inspector informed ZPMC CWI Mr. Zhu Zhong Hai about the lack of paint removal and he instructed the supervisor and workers to remove the paint where dayshift welders will deposit the rest of the weld. See the photographs below for additional information.
